2024 Bridge Week Conference High Load Hit/Request for Action

By: Christopher Idusuyi
Structures Specialist Engineer and
Bridge Emergency Coordinator

March 12-14, 2024

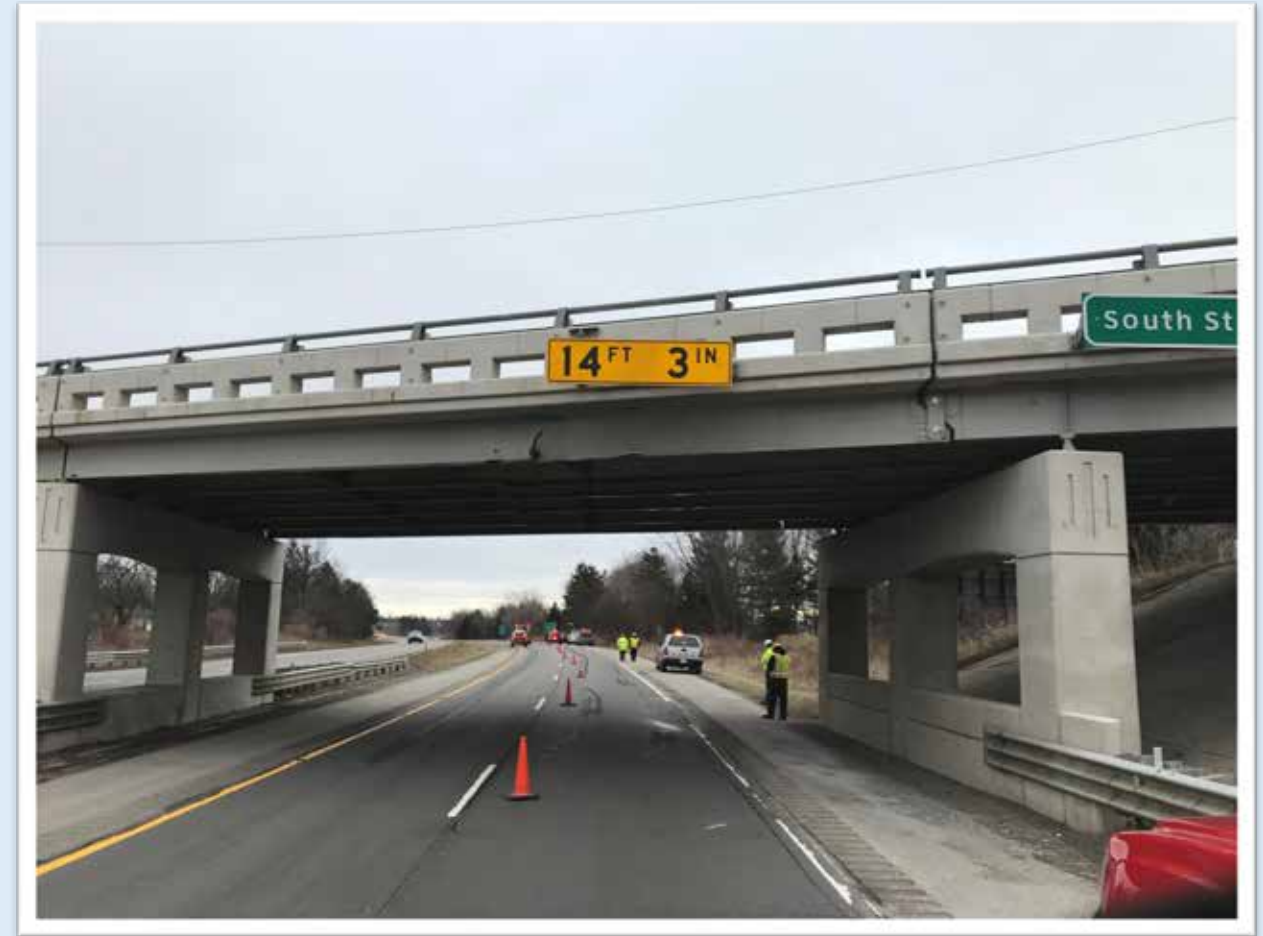
South Street over US 127

- § **Total span length 178' 3.25"**
- § **Built in 1967**
- § **Bridge hit 2 times**
- § **Span 3W with length 50' 6"**
- § **Beams 5S & 6S impacted**
- § **Beam type W27 x 94**
- § **Total estimated cost for repair \$340,033**

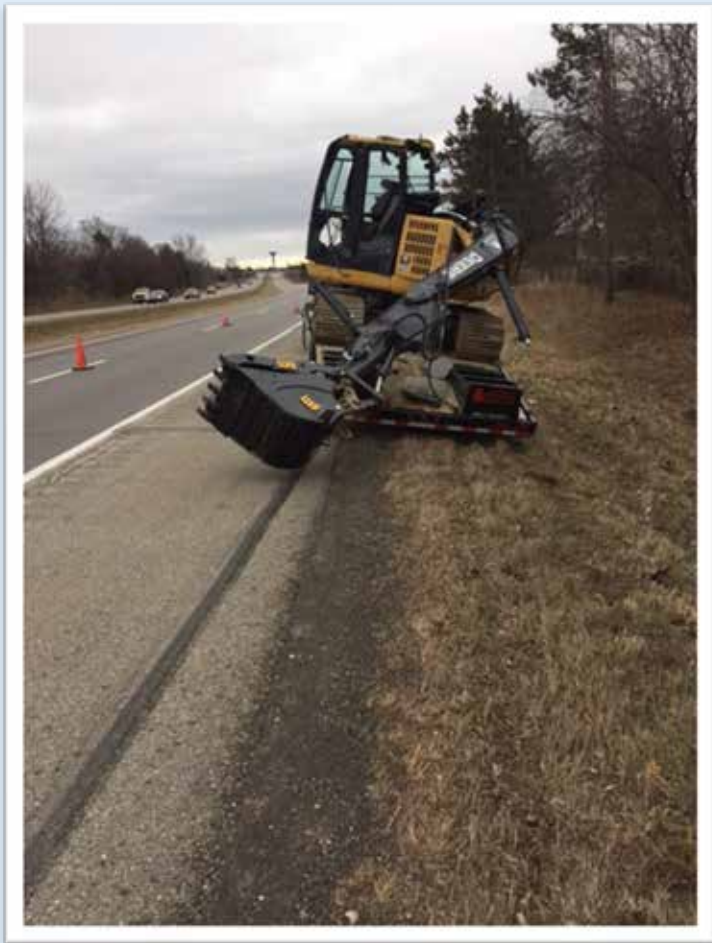
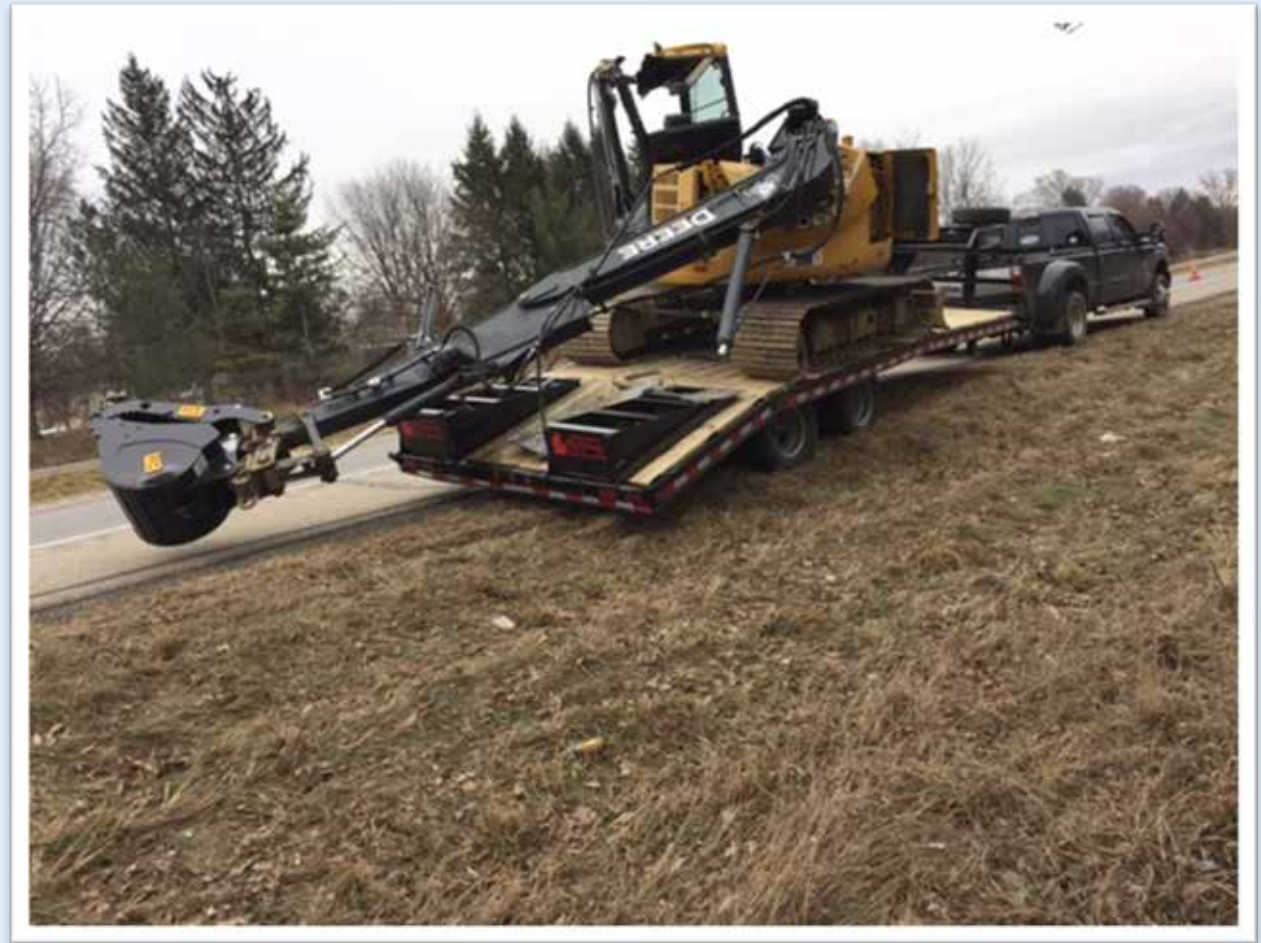
South Street over US 127

Mini-Excavator trailer collided with the bridge

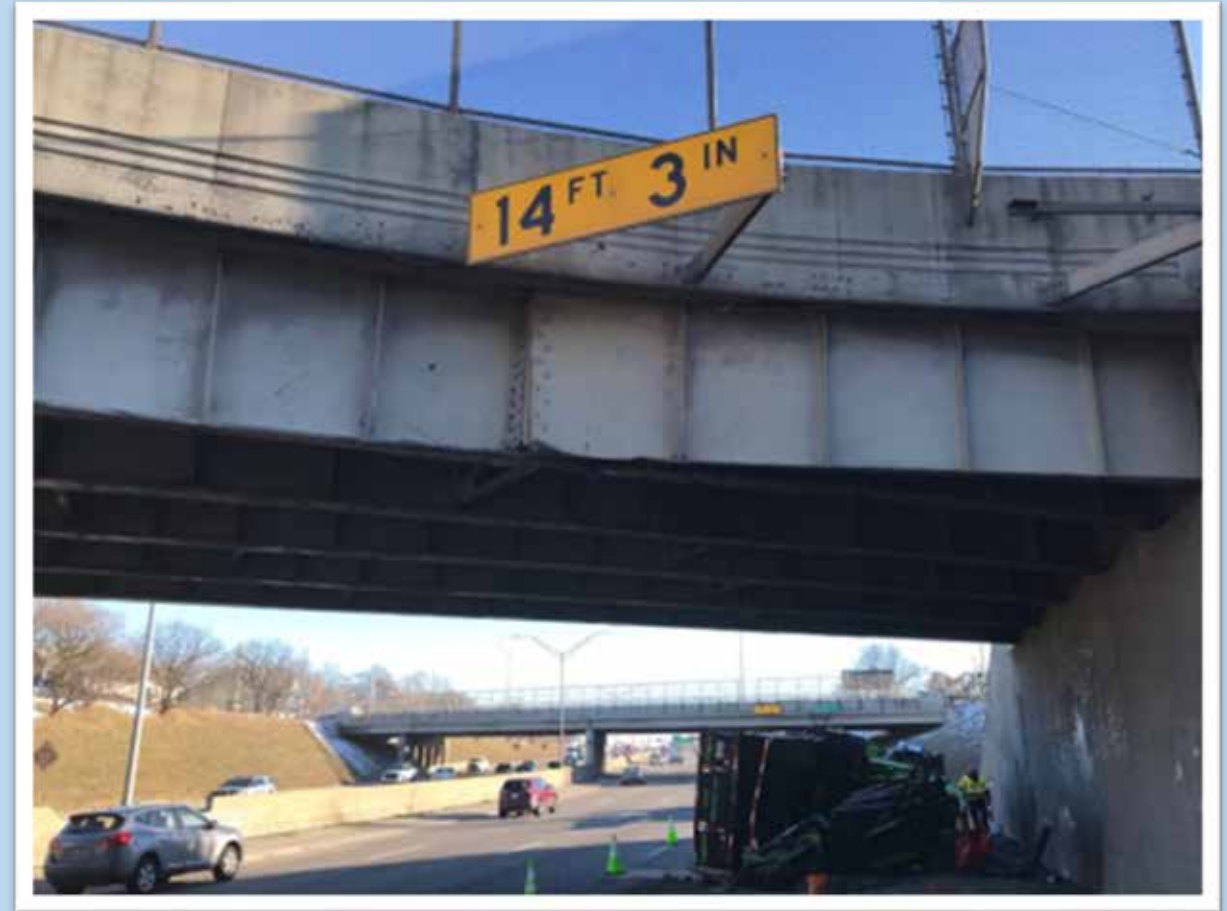
Savannah Road over I-75

- § **Total span length 168' 11"**
- § **Built in 1967**
- § **Bridge hit 1 time**
- § **Span 1W with length 104'**
- § **Beams 5S & flare impacted**
- § **54" web length Girder**
- § **Total estimated cost for repair \$276,853**

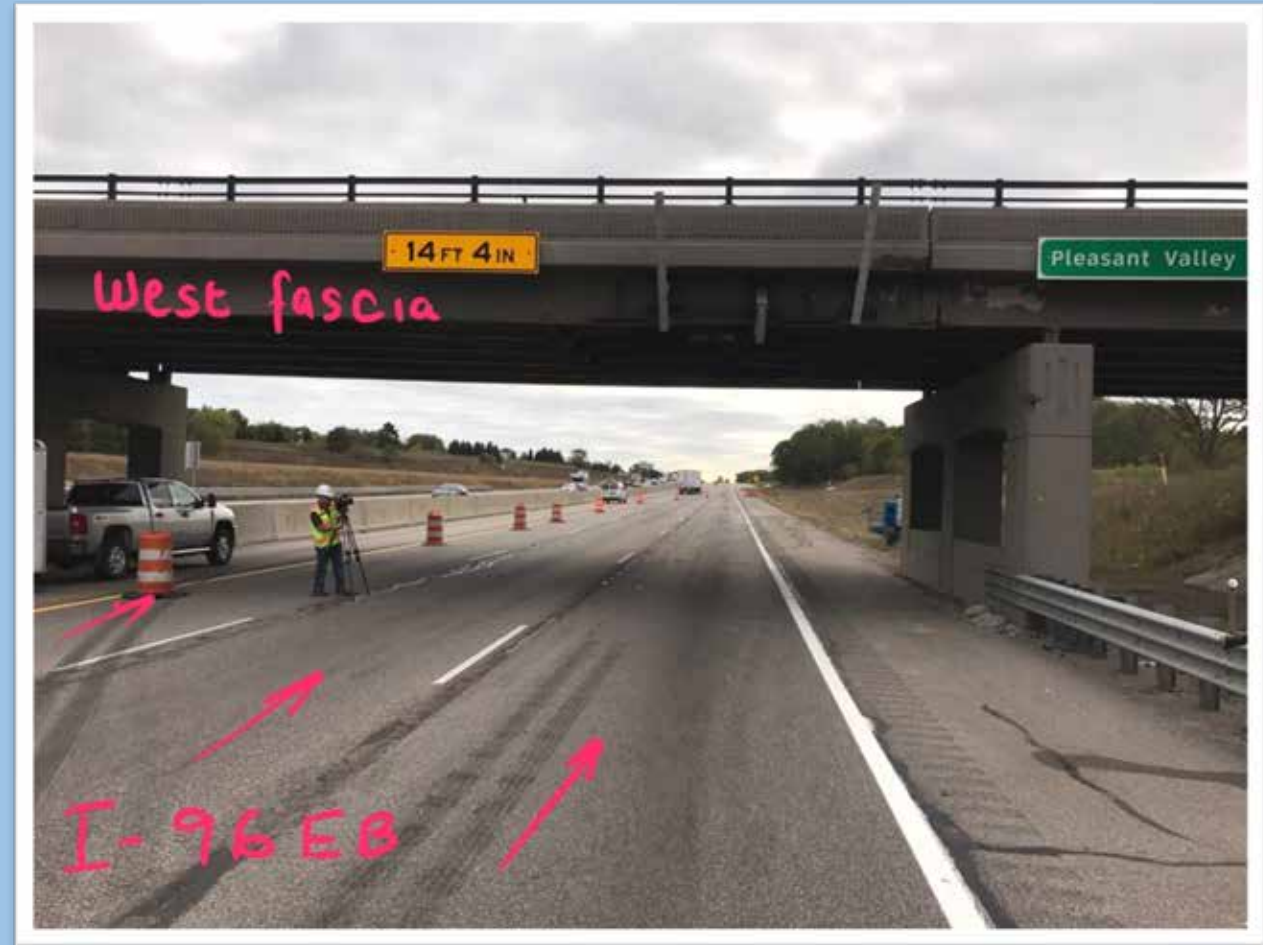
Pleasant Valley Rd over I-96

- § Total span length 231'
- § Built in 1958
- § Bridge hit 2 times
- § Span 2S with length 65' 6"
- § Beams 1W through 4W impacted
- § Beam type W33 x 141
- § Total estimated cost for repair \$581,665

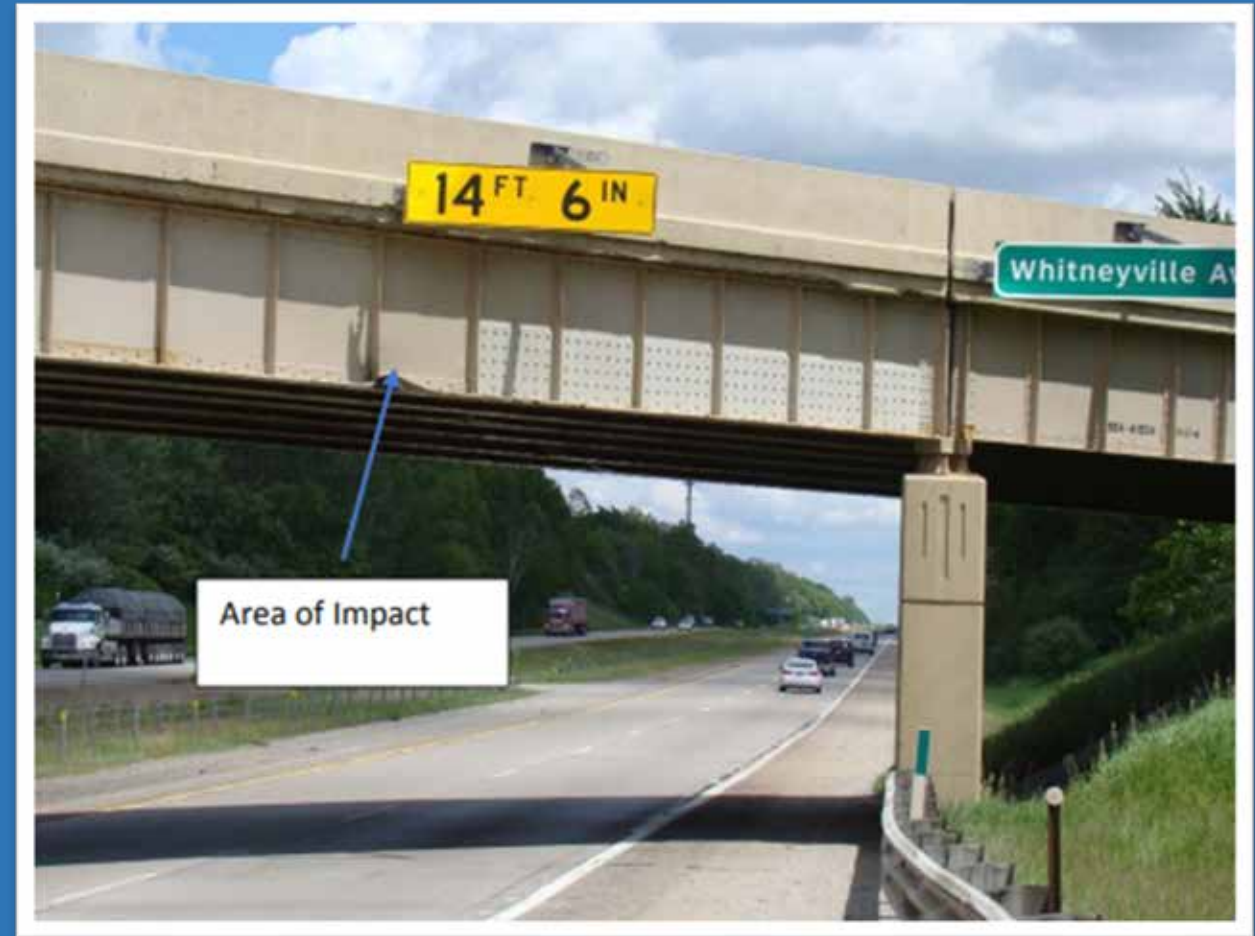
Whitneyville Road over I-96

- § Total span length 275' 6"
- § Built in 1959
- § Bridge hit 3 times
- § Span 3S with length 65' 6"
- § Beams 1W through 6W impacted
- § 60" web length Girder
- § Total cost for repair \$75,107.61

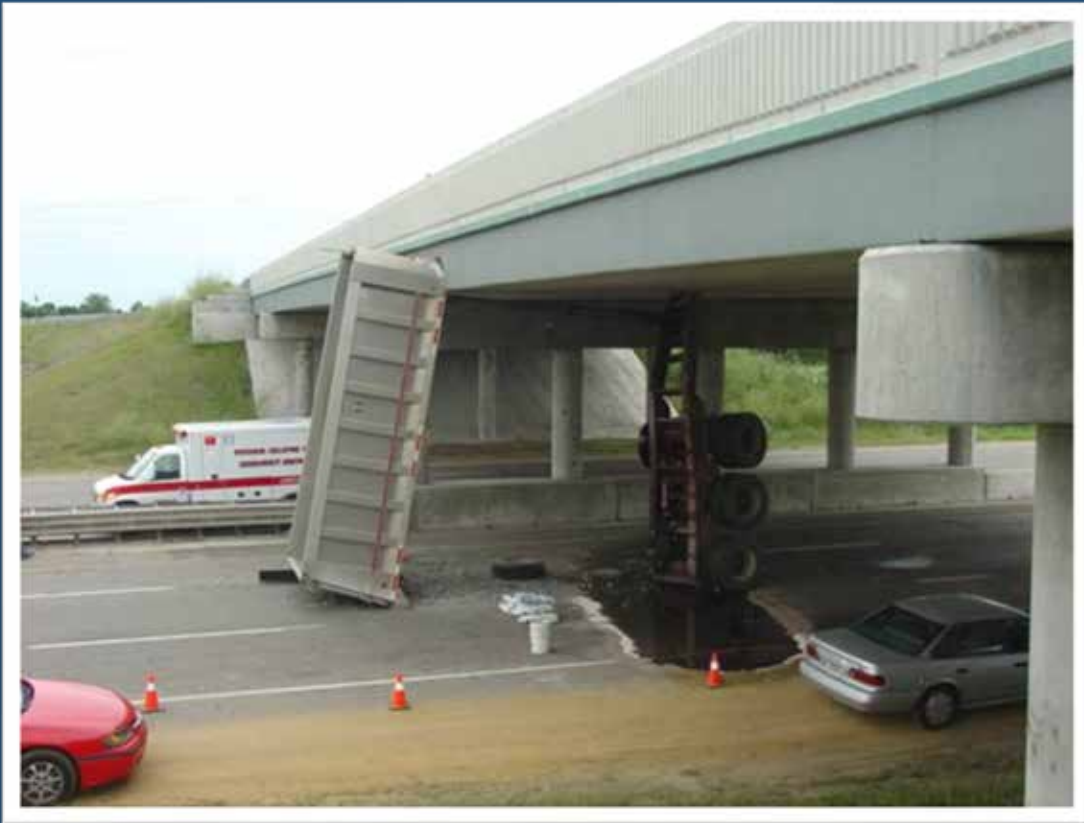
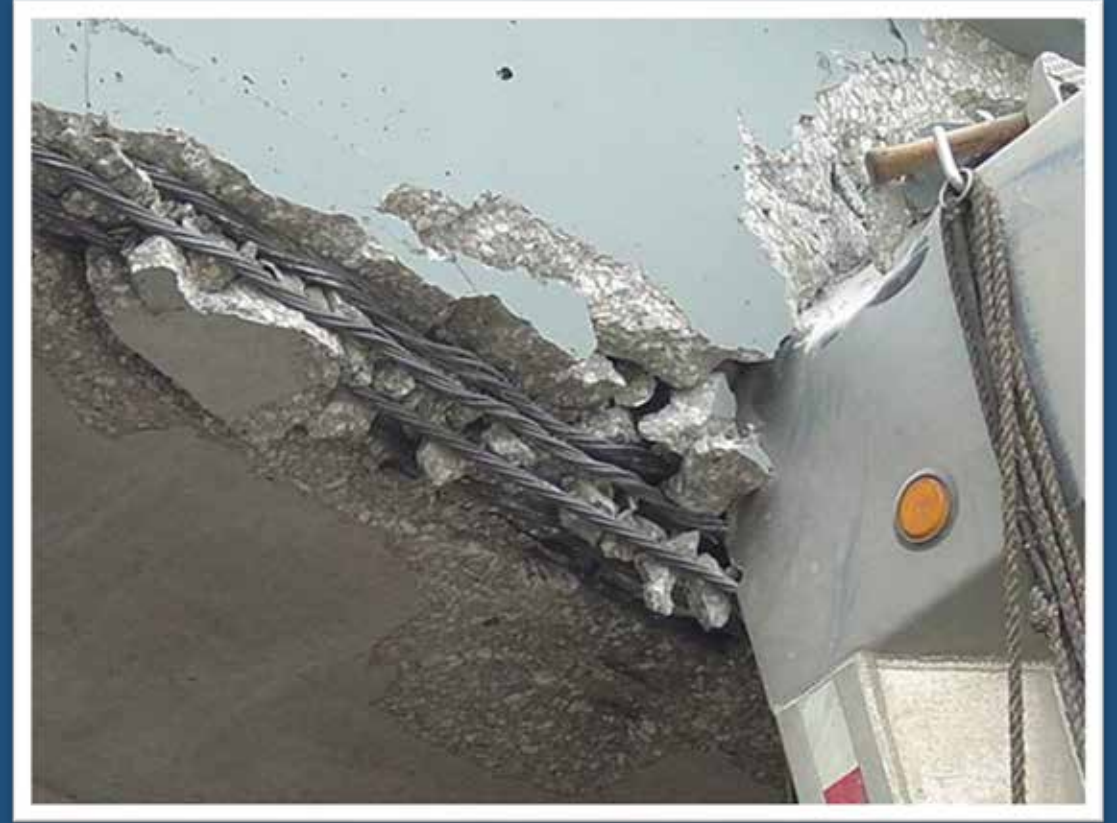
I-96 over Lansing Road

Box beams, several strands broken, Design (Jeff Triezenberg's Unit) prepared contract plans

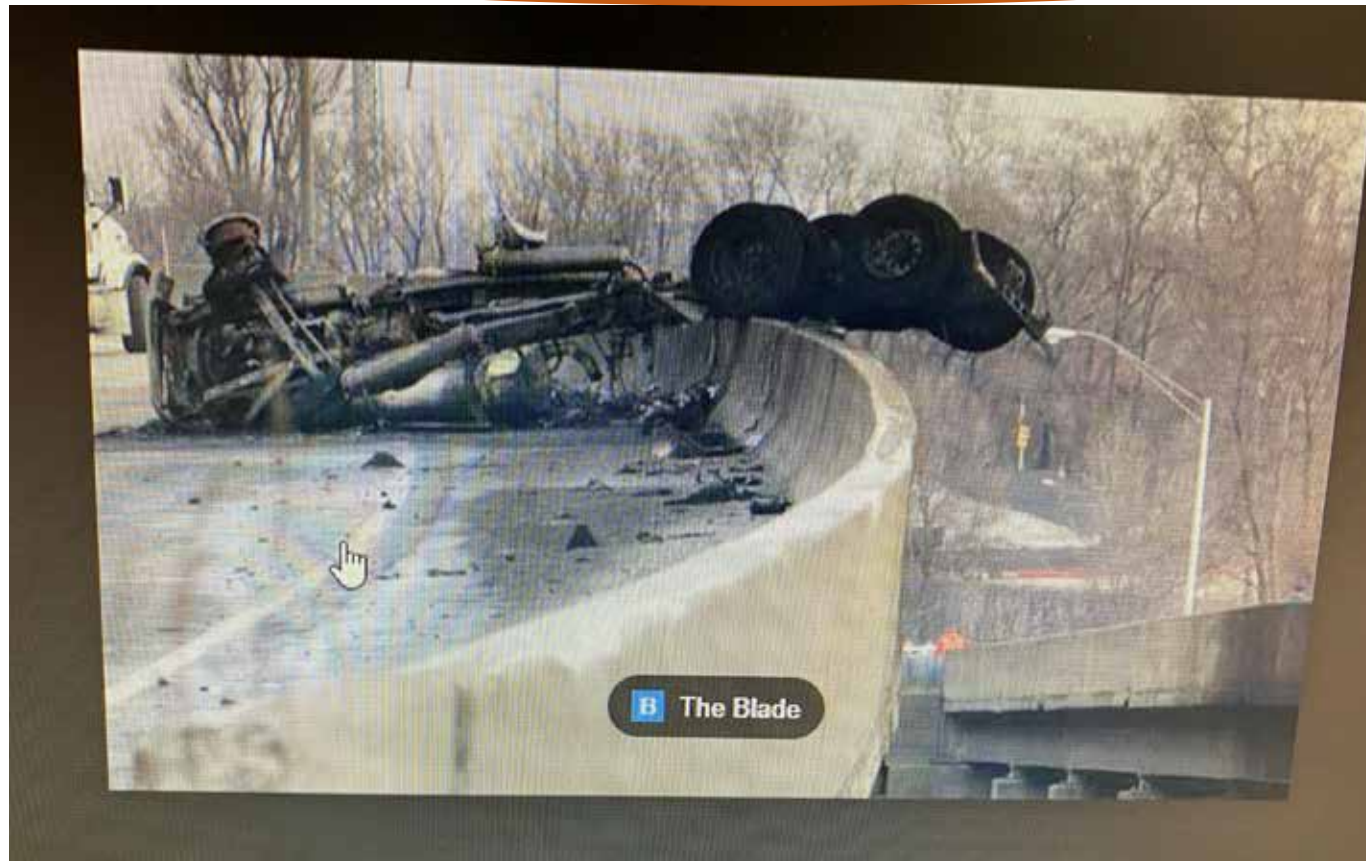
Fire damage on I-75 over Rouge River

- Tanker Truck Explosion caused severe fire damage
- Superstructure and substructure were damaged

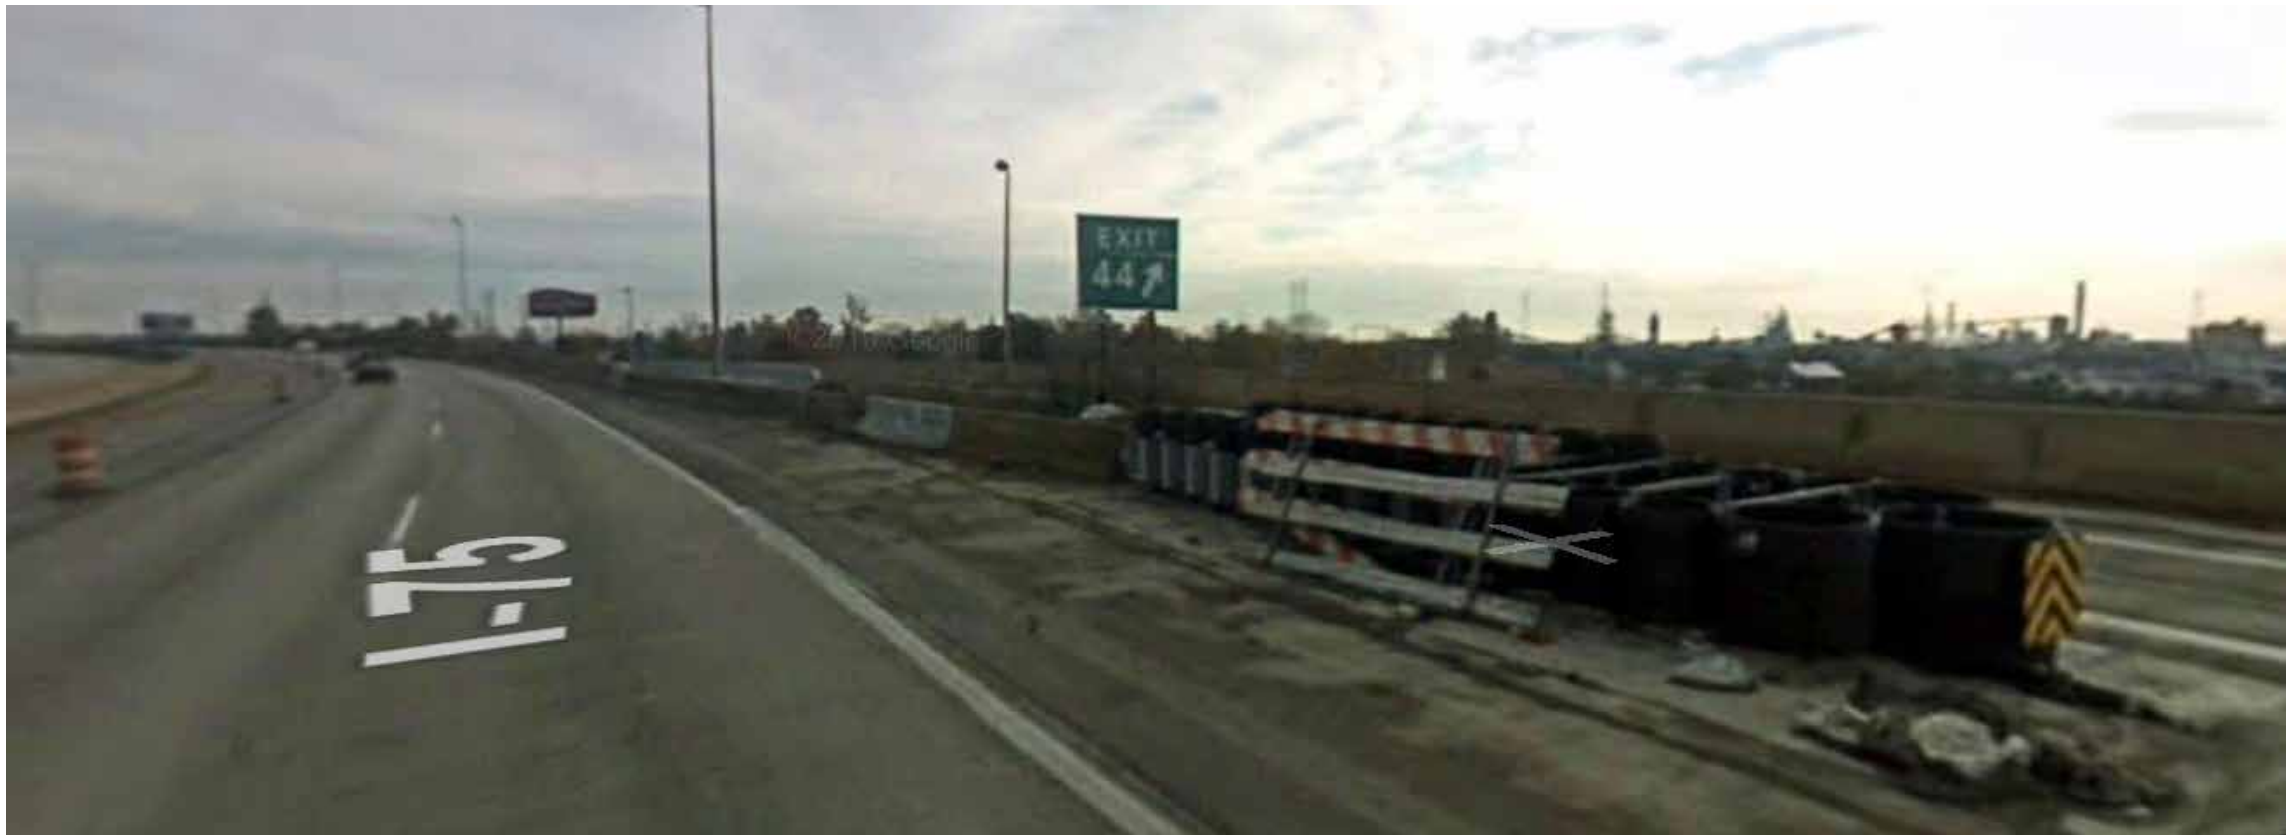
Fire damage on I-75 over Rouge River

- Tanker Truck Explosion caused severe fire damage
- Superstructure and substructure were damaged

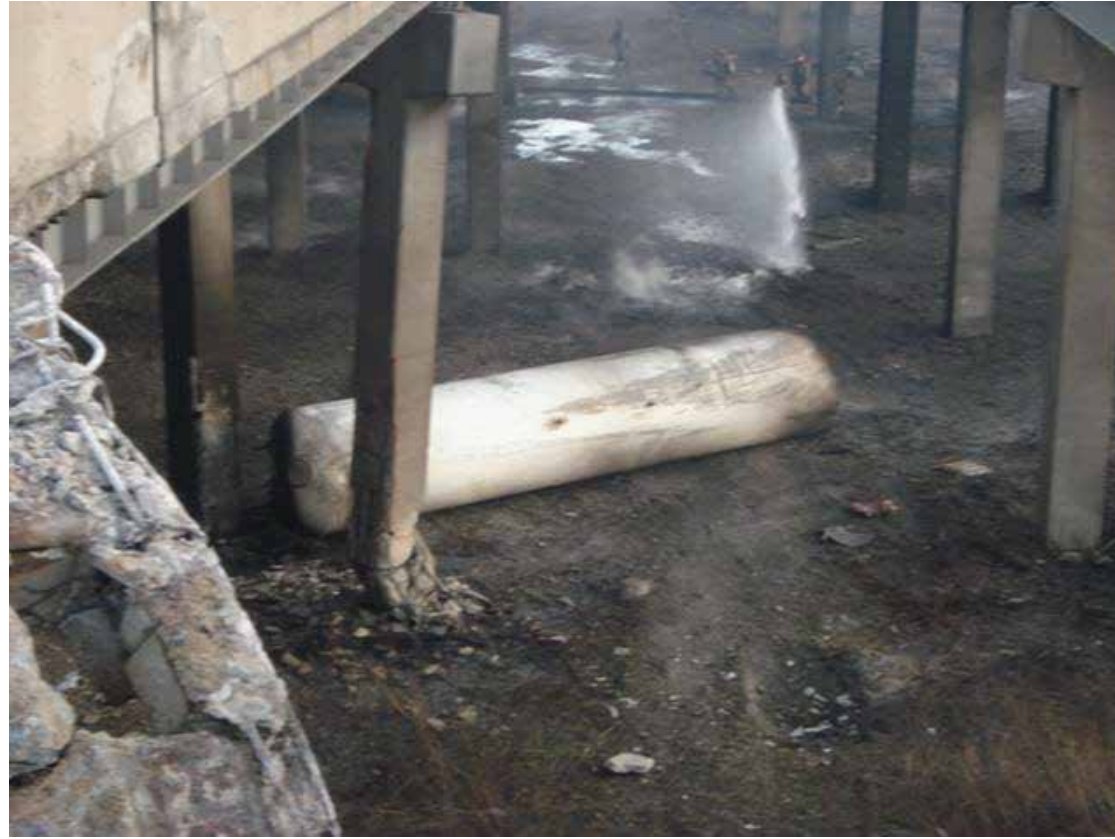
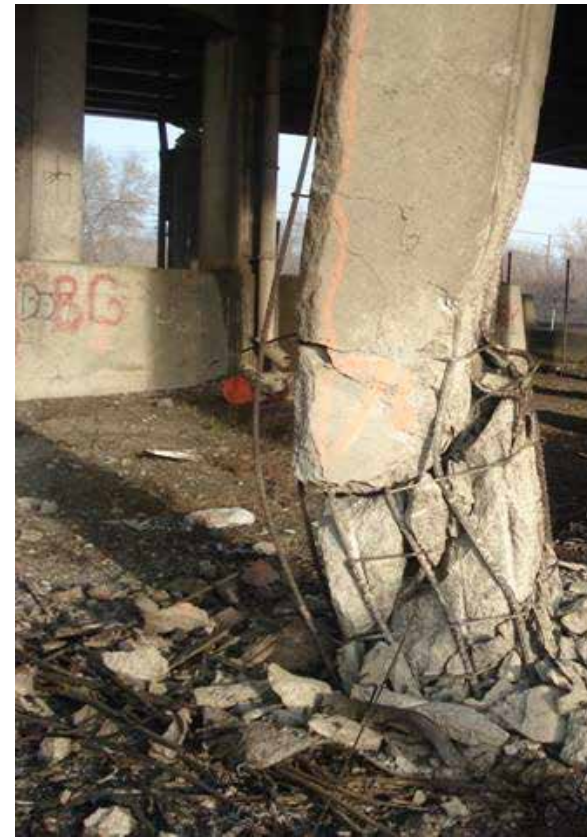
Fire damage on I-75 over Rouge River

- Tanker Truck Explosion caused severe fire damage
- Superstructure and substructure were damaged

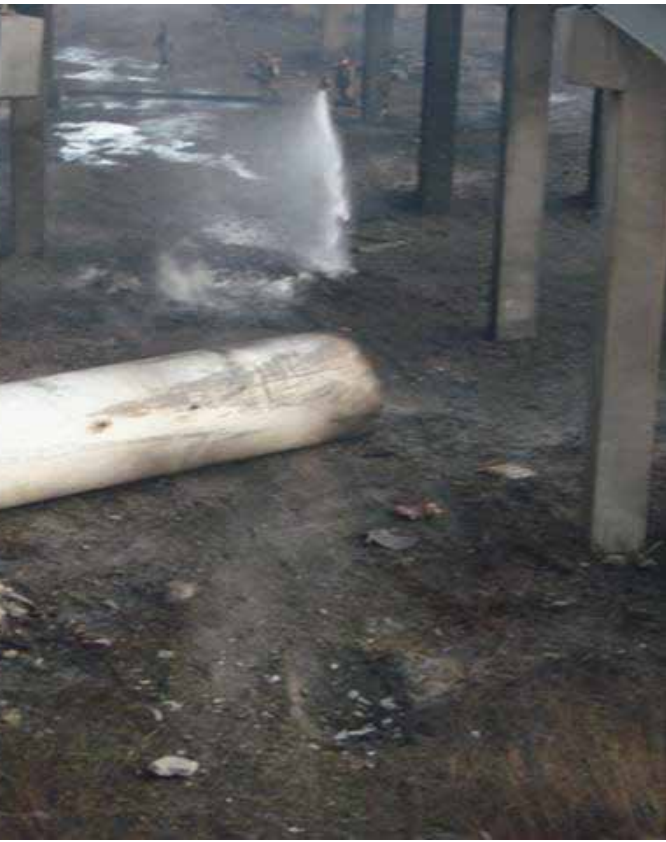
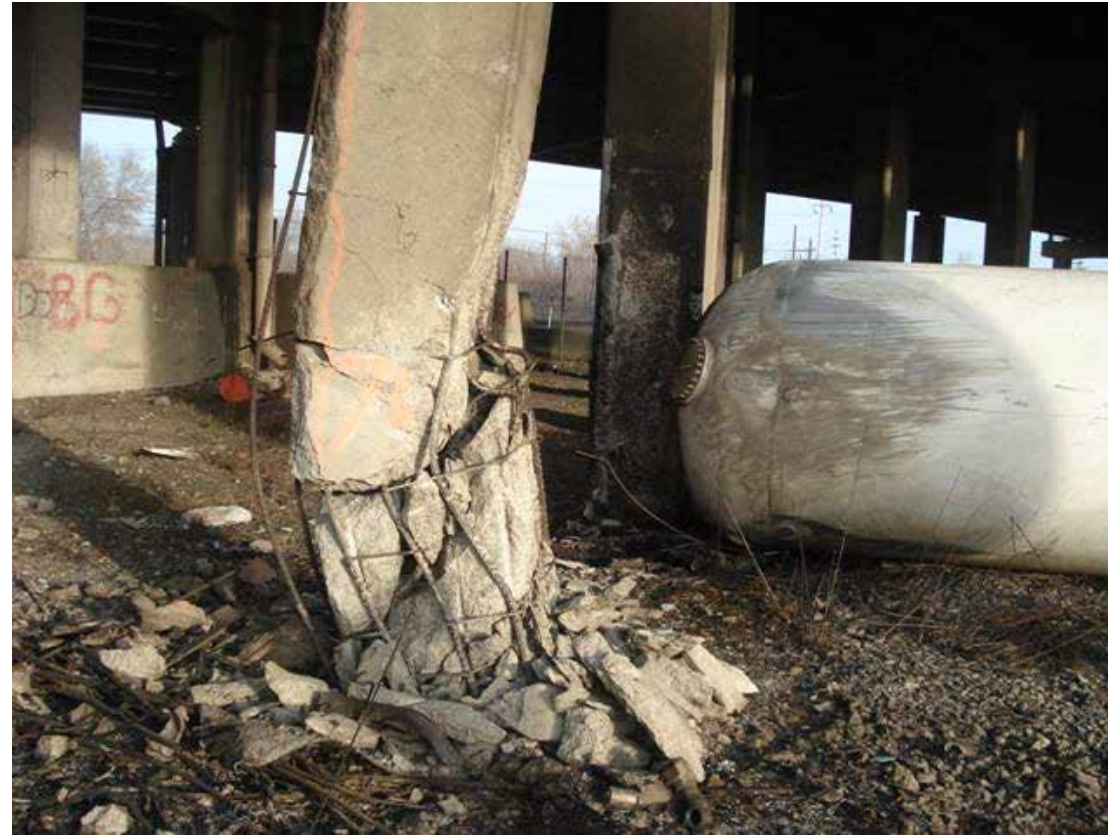
Fire damage on I-75 over Rouge River

- Tanker Truck Explosion caused severe fire damage
- Superstructure and substructure were damaged

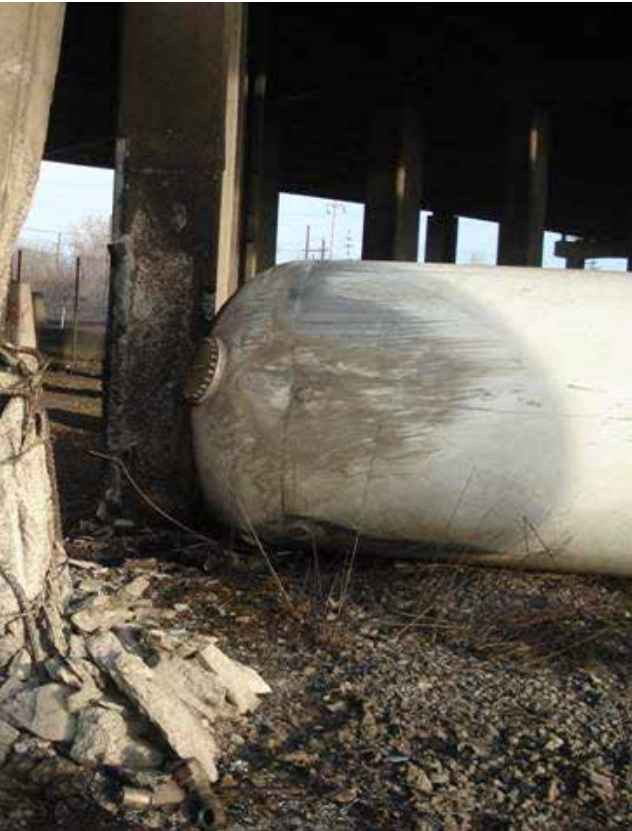
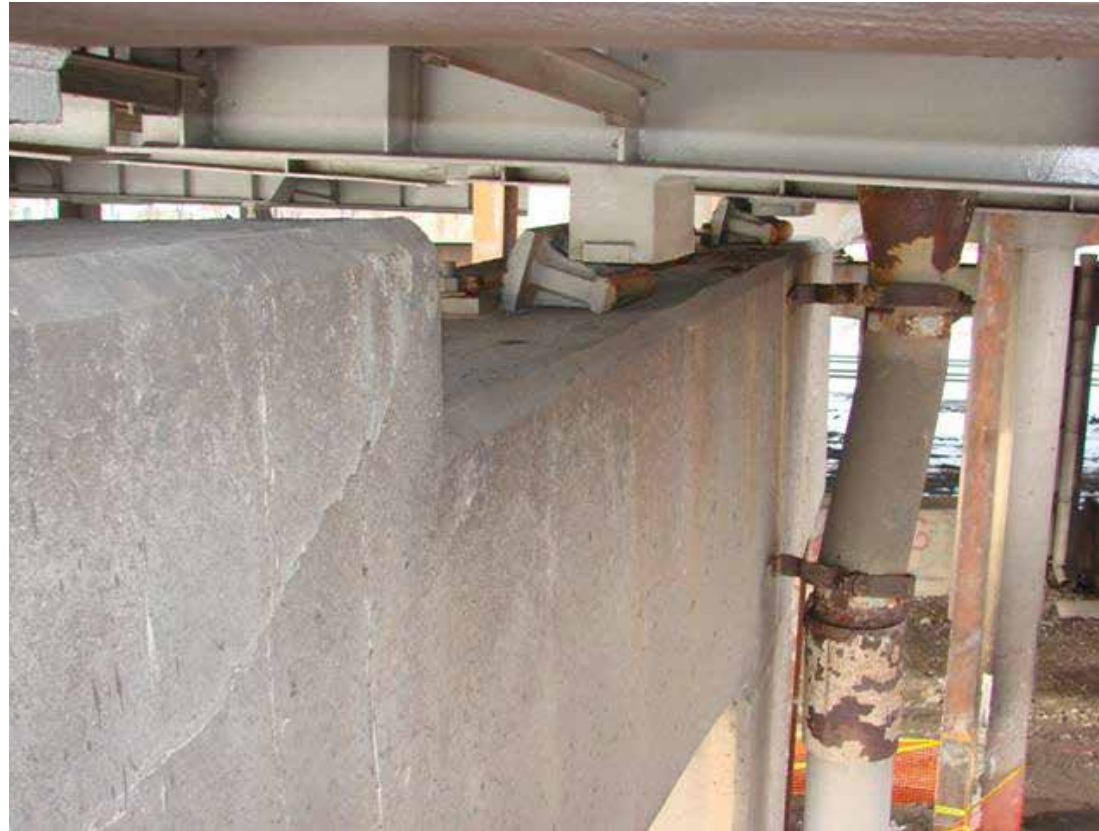
Fire damage on I-75 over Rouge River

- Tanker Truck Explosion caused severe fire damage
- Superstructure and substructure were damaged

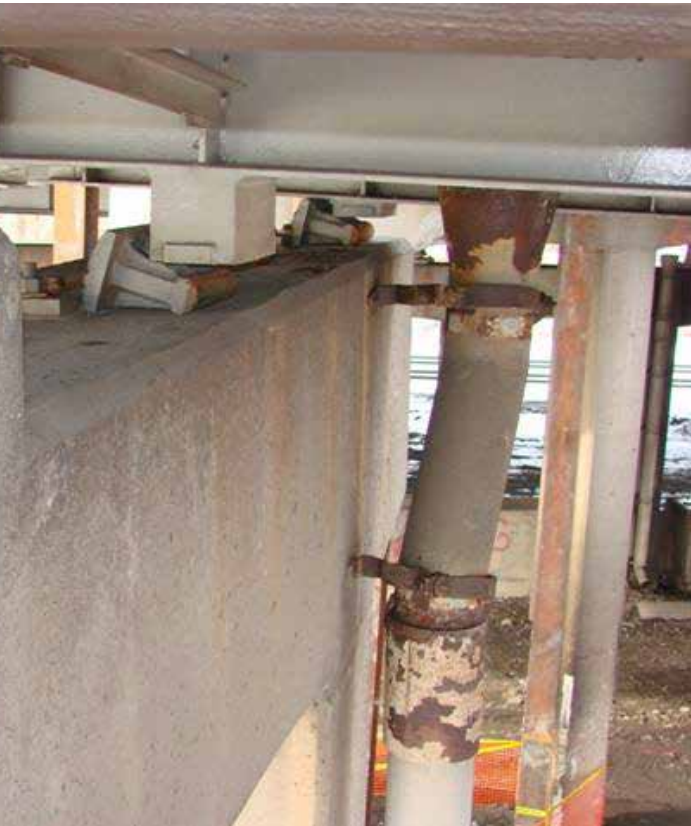
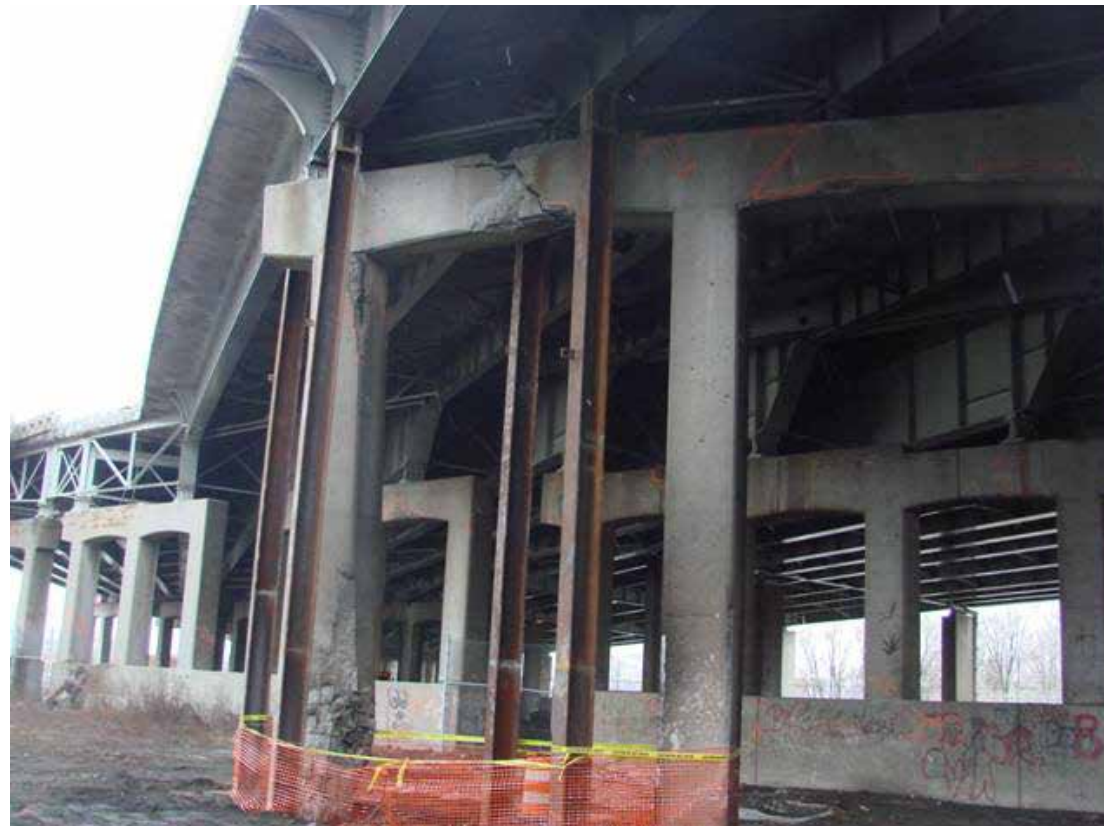
Fire damage on I-75 over Rouge River

- Tanker Truck Explosion caused severe fire damage
- Superstructure and substructure were damaged

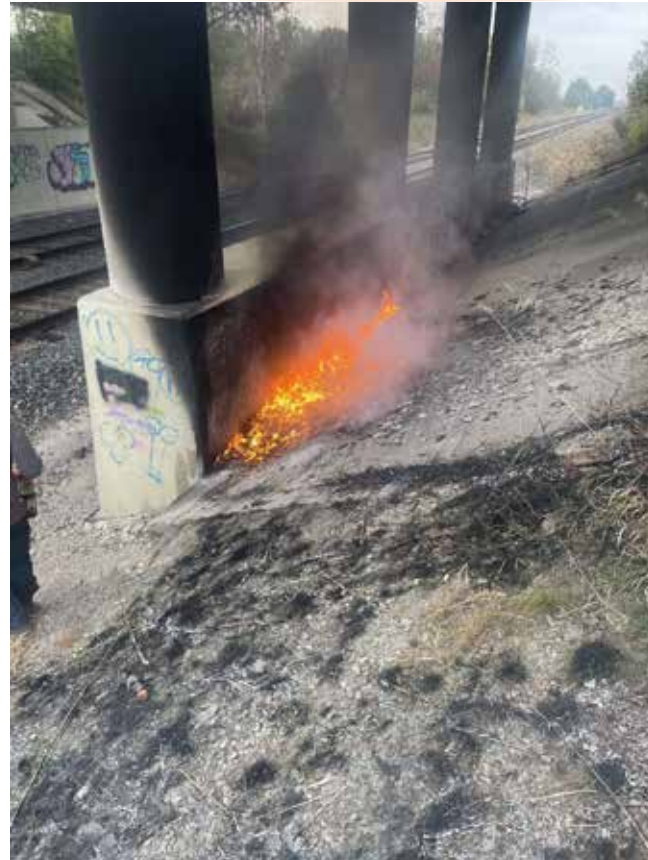
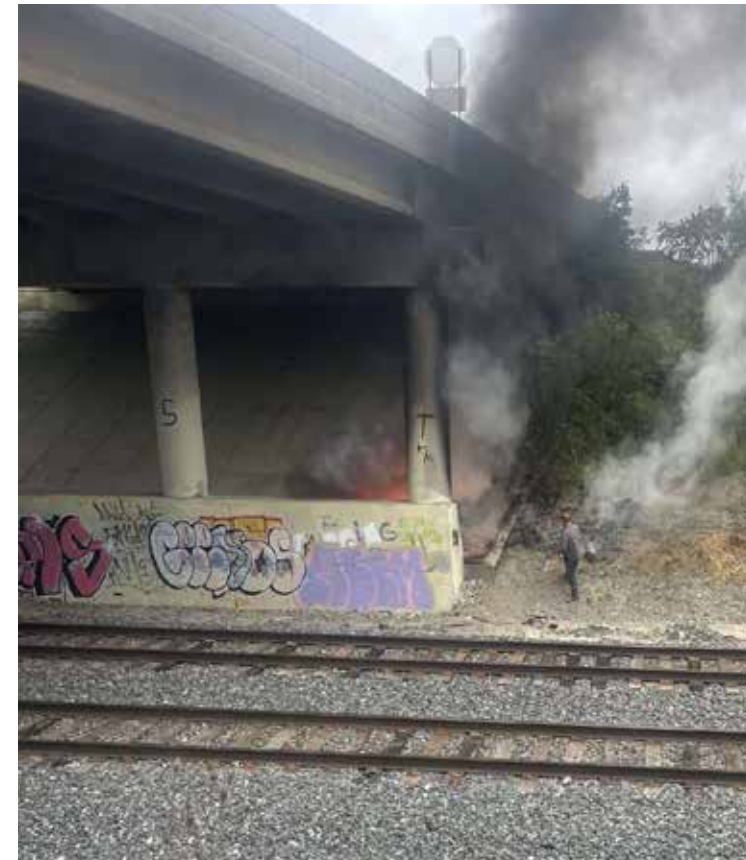
Fire damage on I-75 over MDOT RR Corridor

- Brush fire caused by kids
- Black soot covers south face of Pier 1S

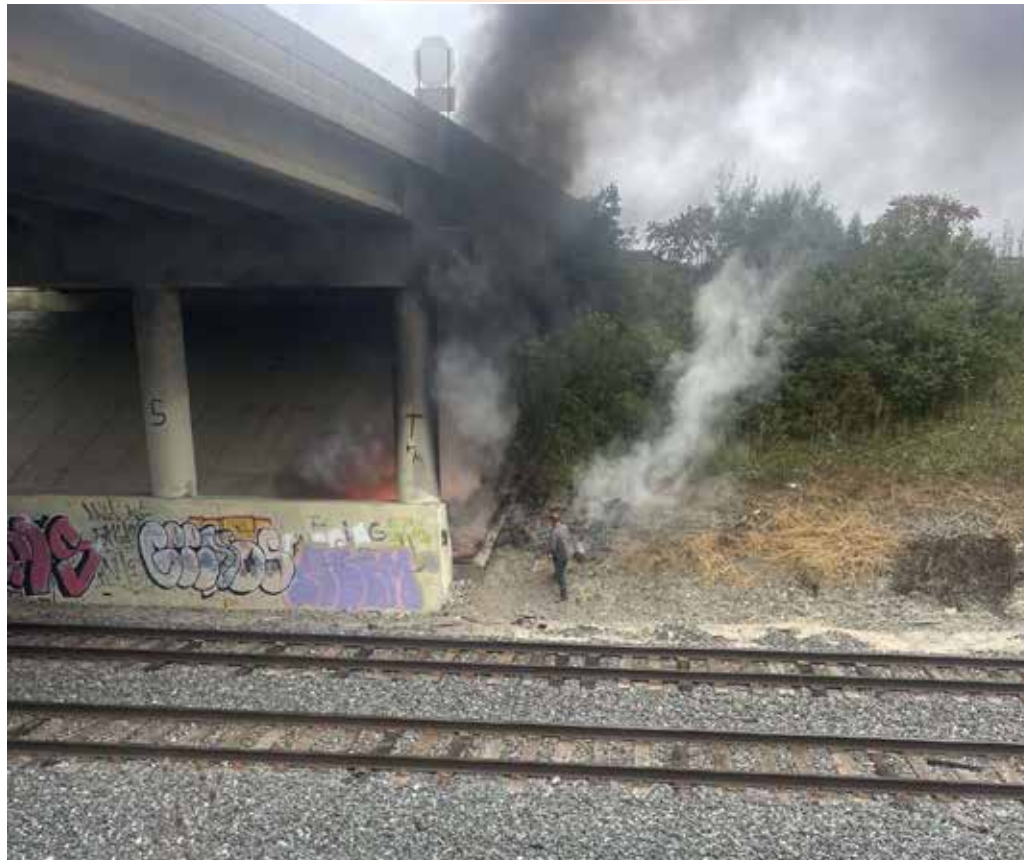
Fire damage on I-75 over MDOT RR Corridor

- Brush fire caused by kids
- Black soot covers south face of Pier 1S

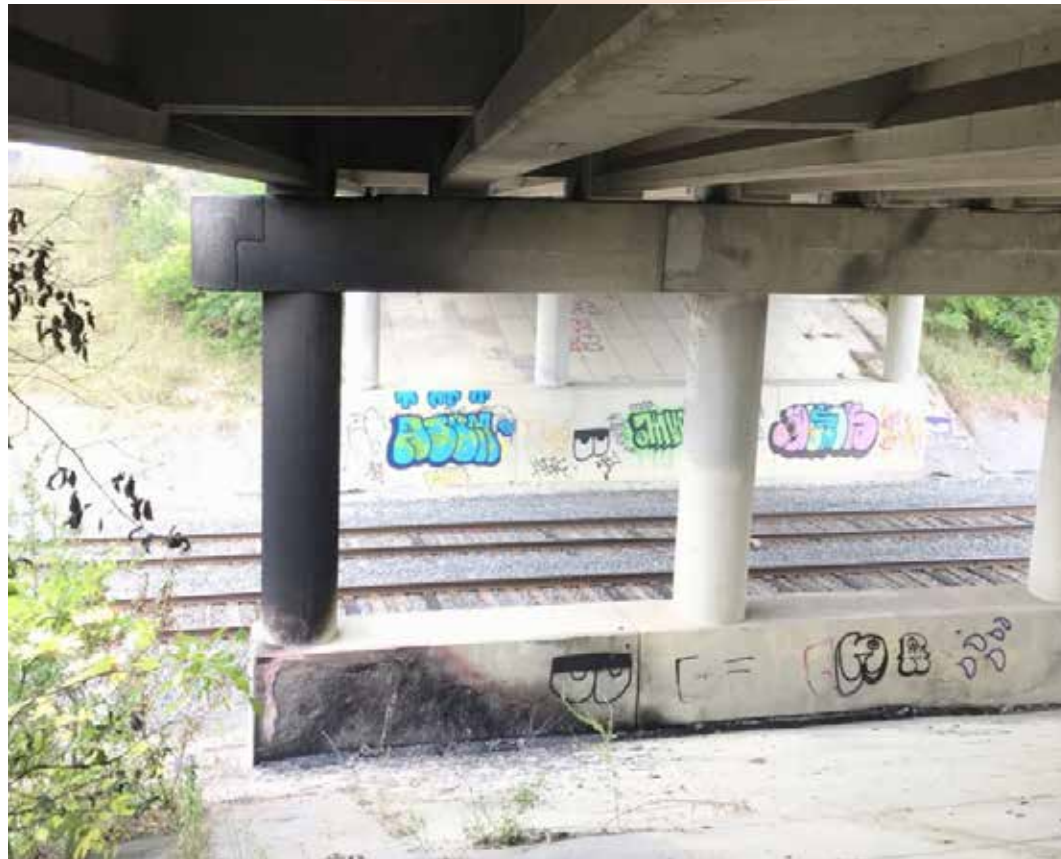
Fire damage on I-75 over MDOT RR Corridor

- Brush fire caused by kids
- Black soot covers south face of Pier 1S

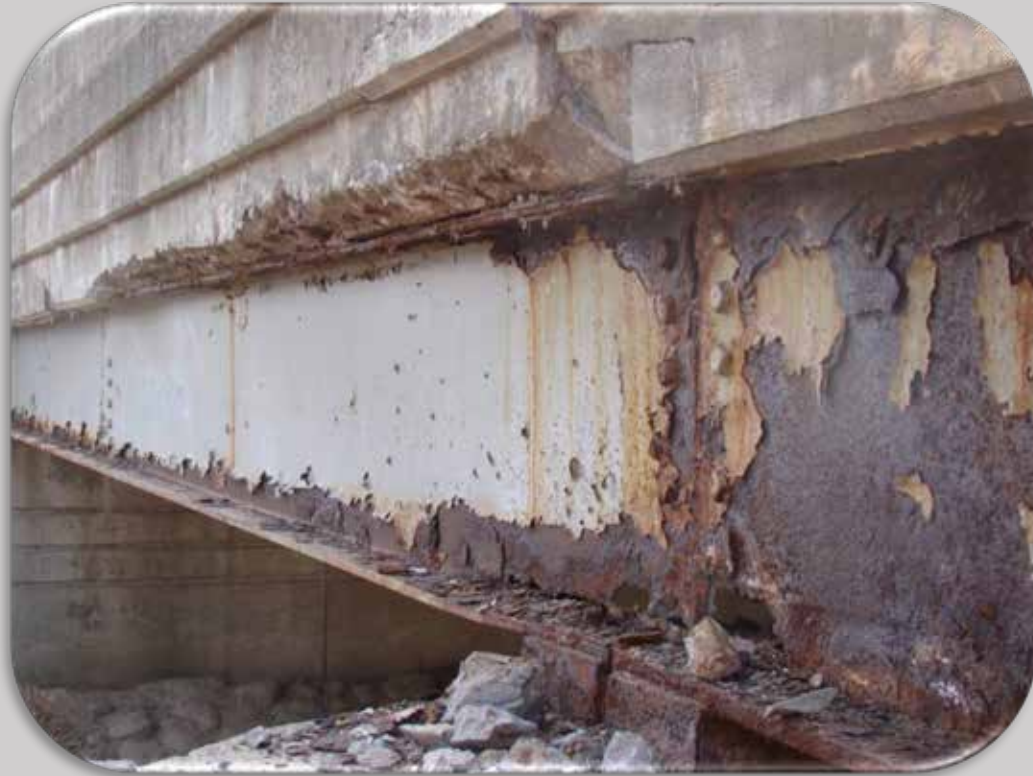
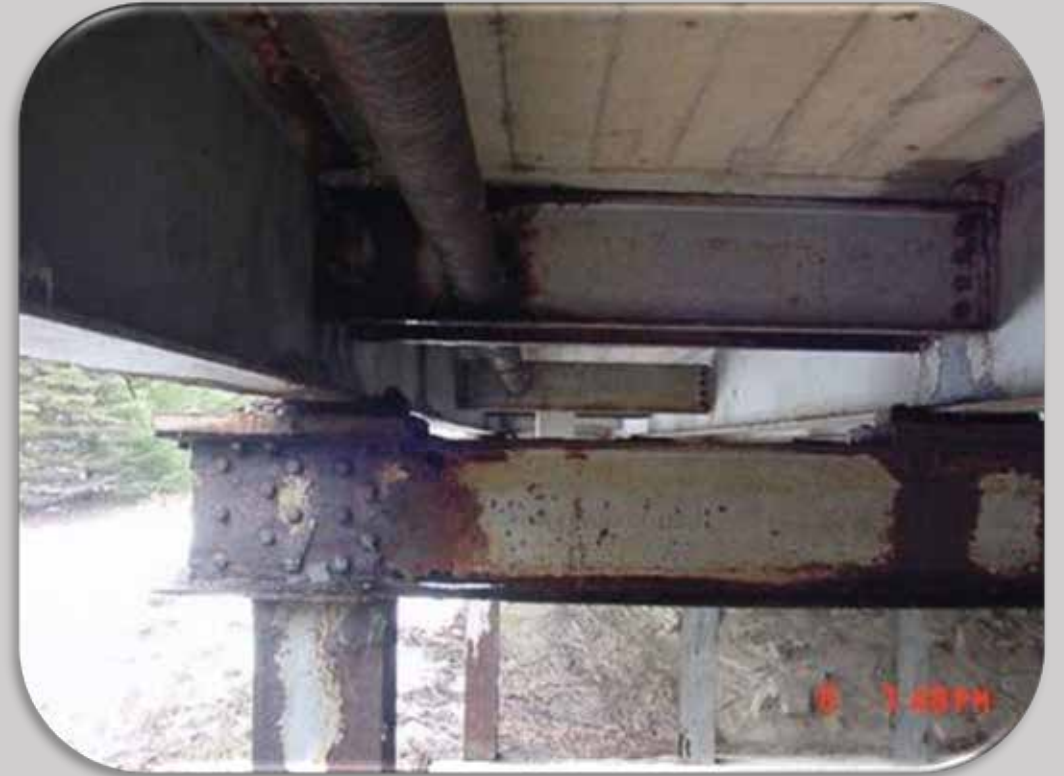
Section Loss

Cracked, holes/buckled beam and pier cap (corrosion)
