2024 Bridge Week Conference High Load Hit/Request for Action

By: Christopher Idusuyi
Structures Specialist Engineer and
Bridge Emergency Coordinator

March 12-14, 2024

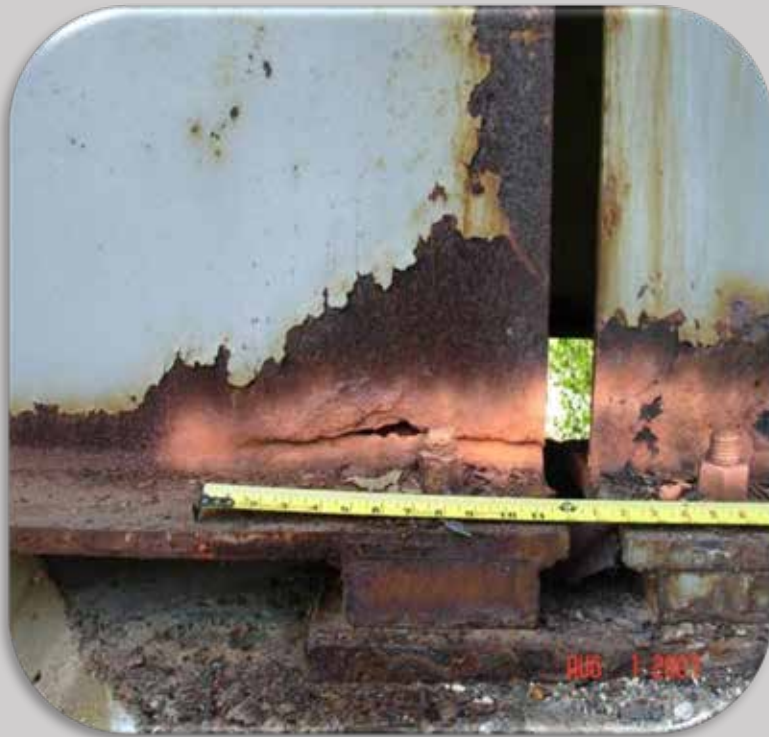
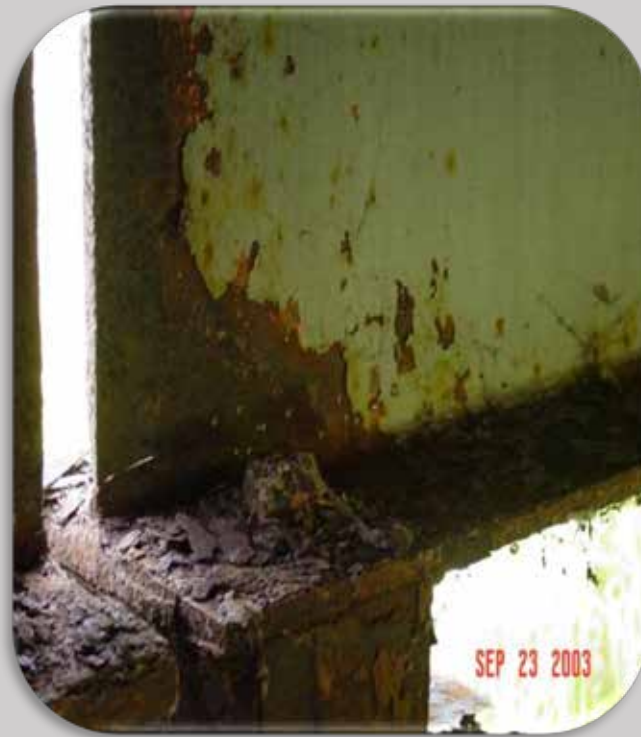
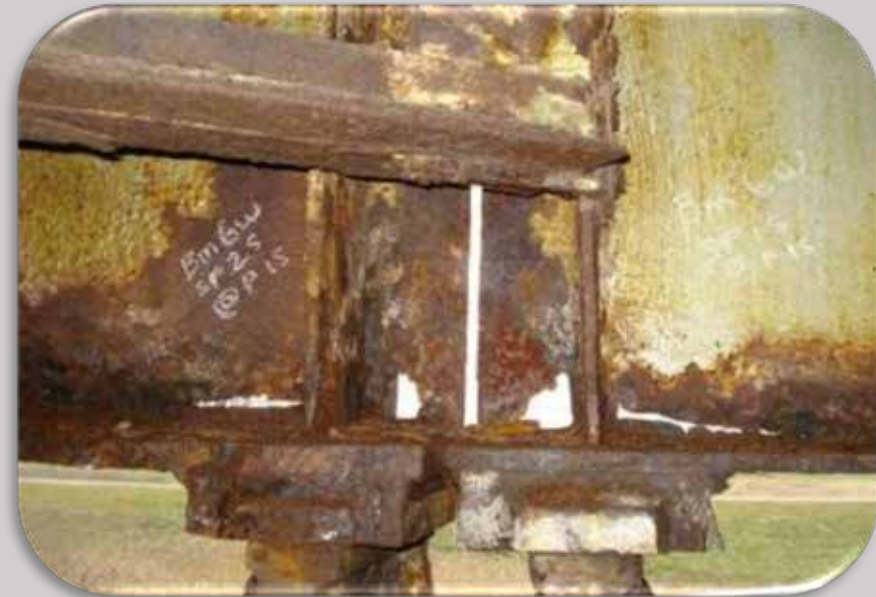
Section Loss

Cracked Beam Ends

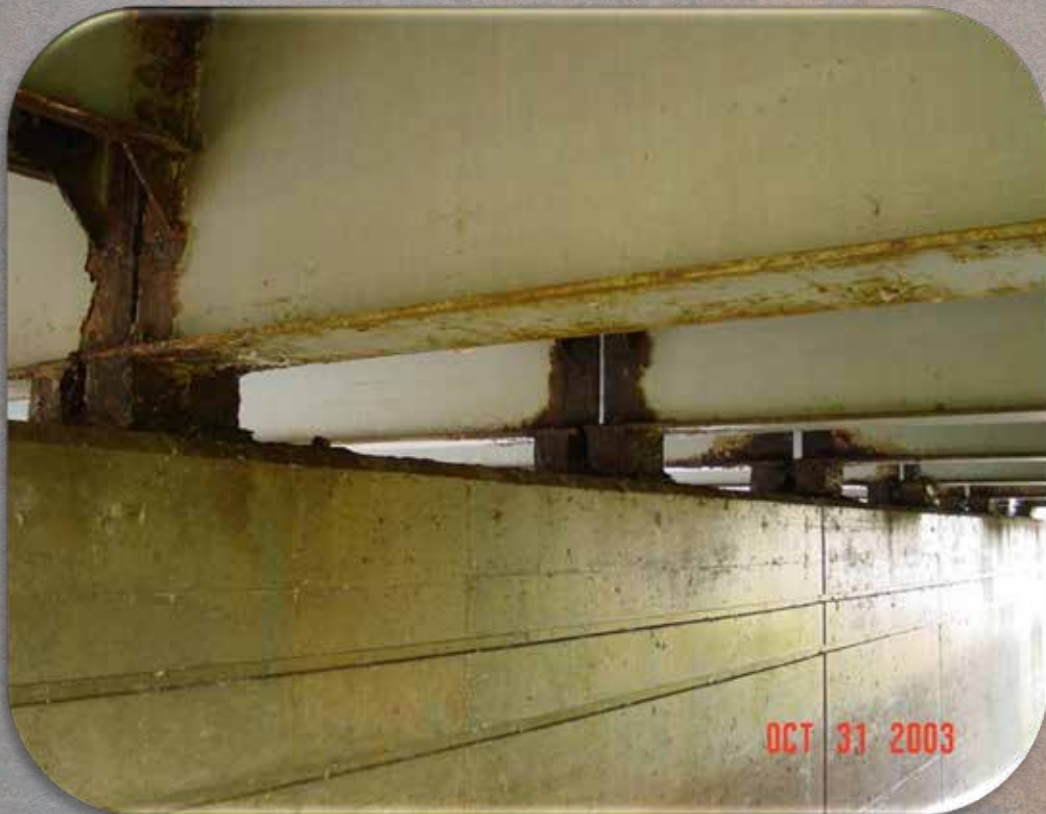
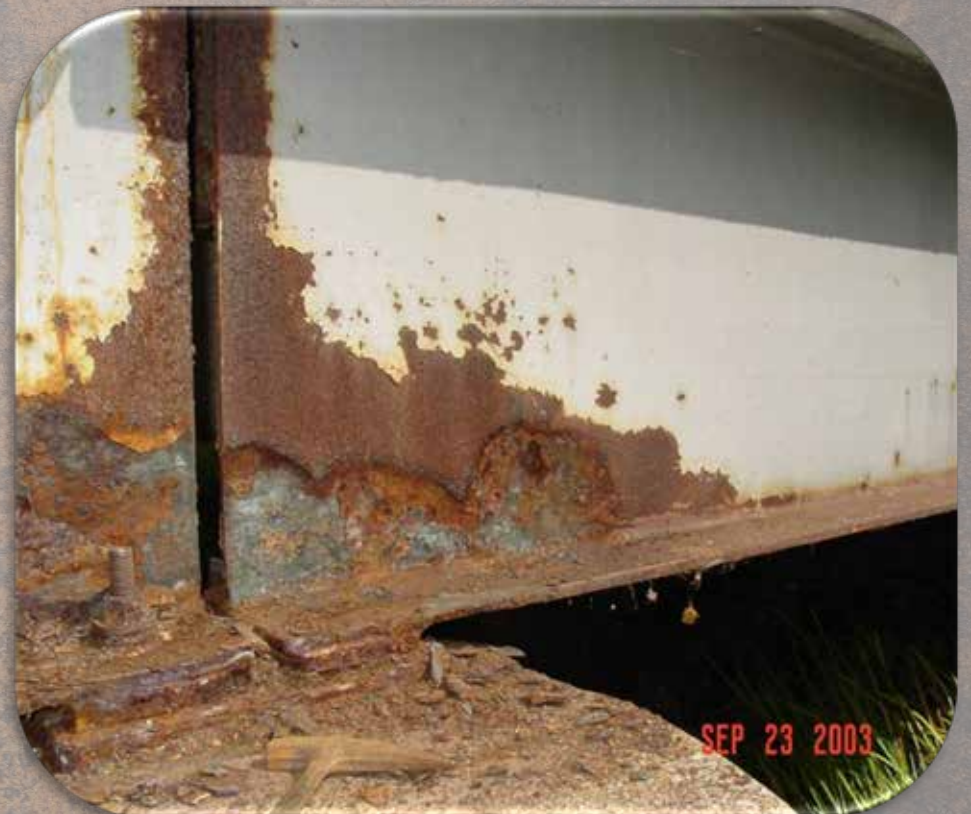
- **Beam Ends with Section Loss**
 - **Analysis by Load Rating Engineer**

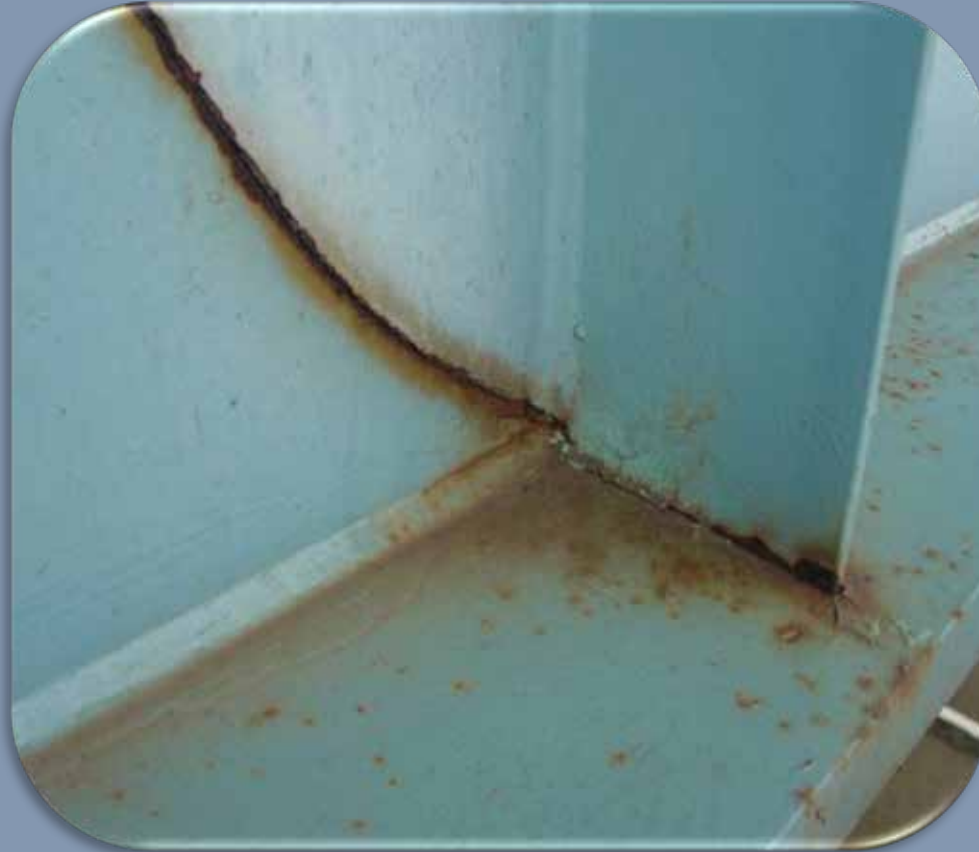
- Fatigue damage (cracked beam)
- Web/stiffener connection
- Fatigue crack because of no weld gap (intersecting weld)

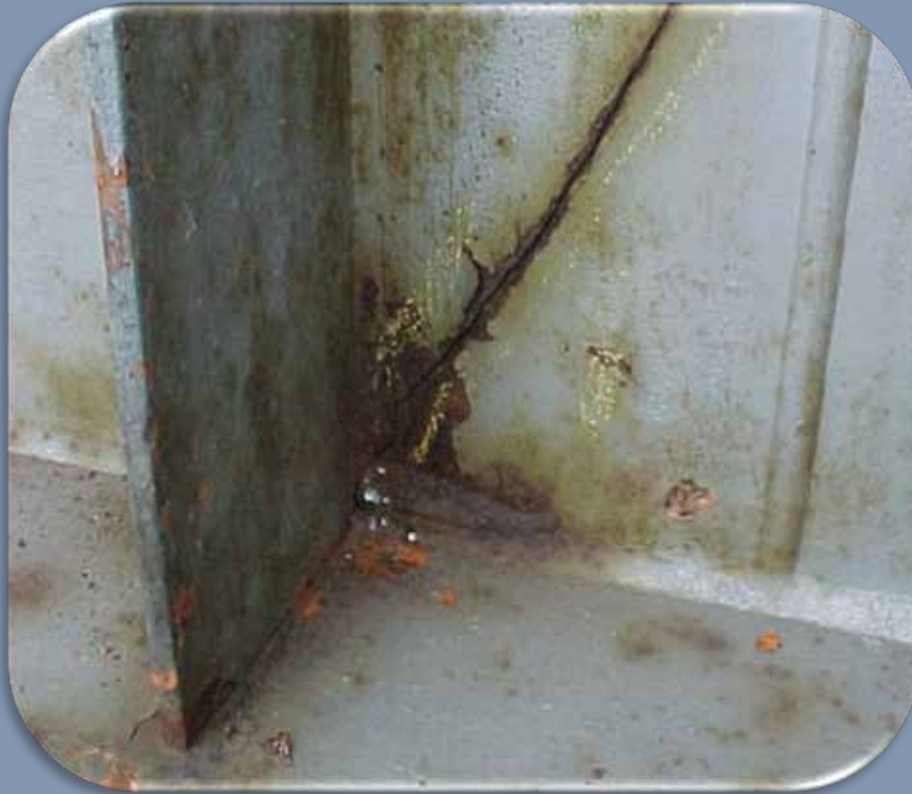
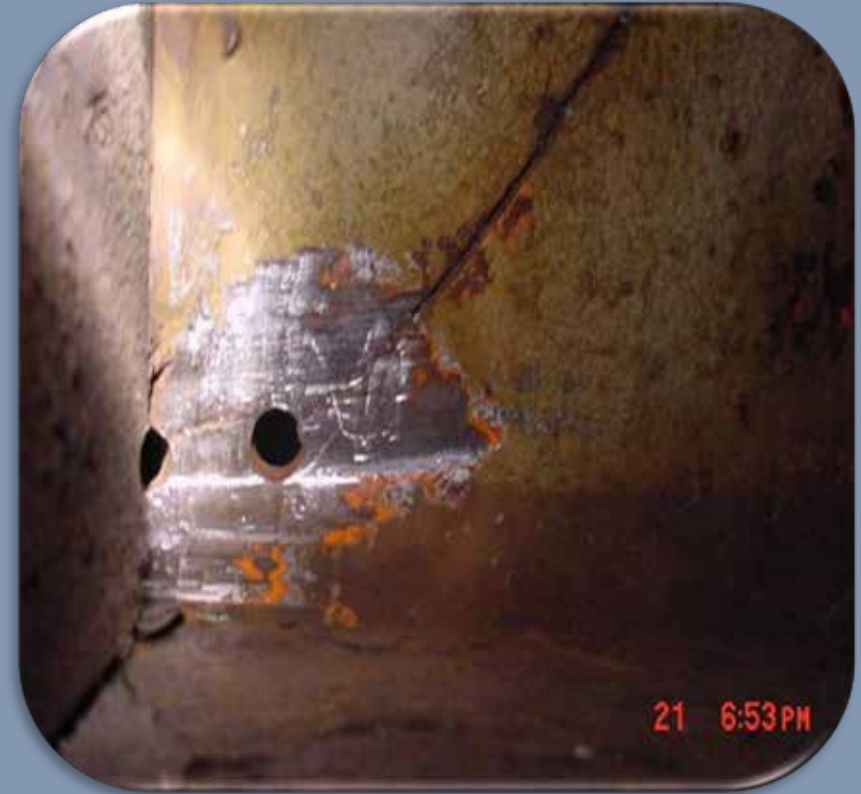
Fatigue

Fatigue Crack

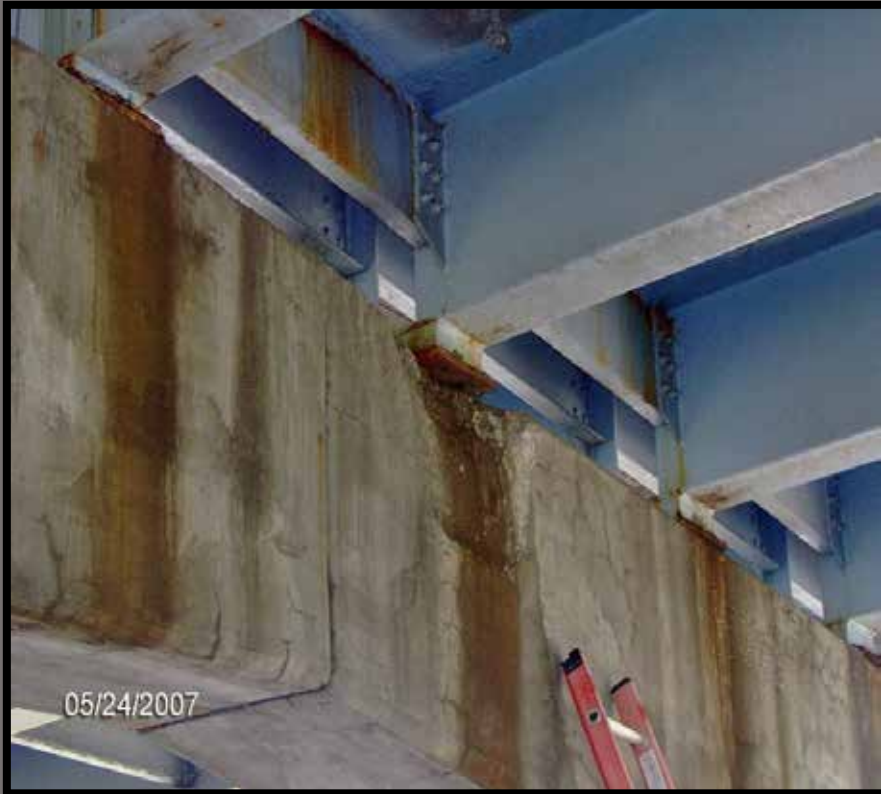
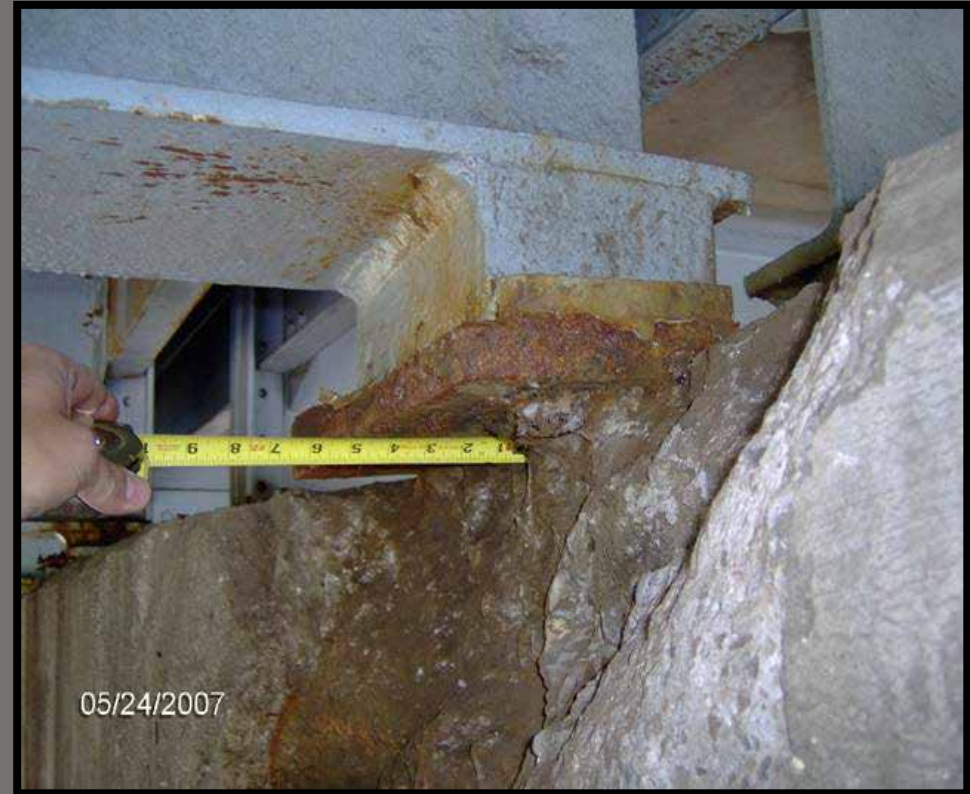
Concrete Delamination/Deterioration

Loss of Bearing Area

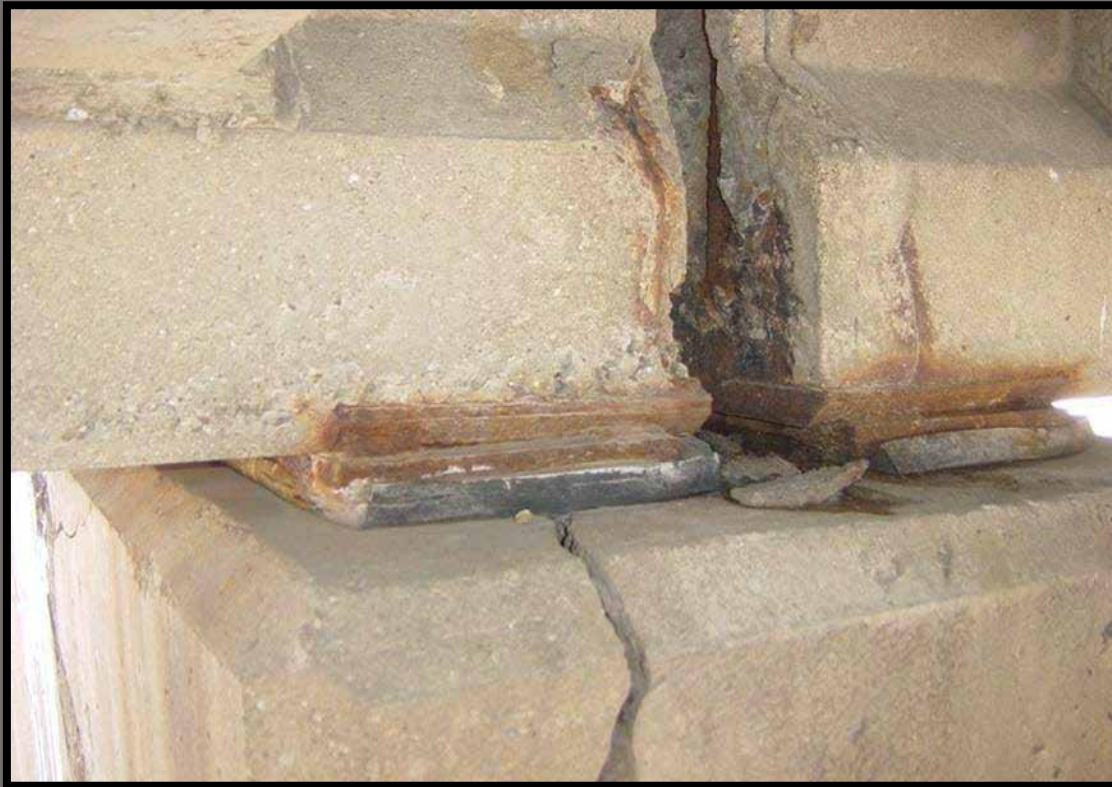
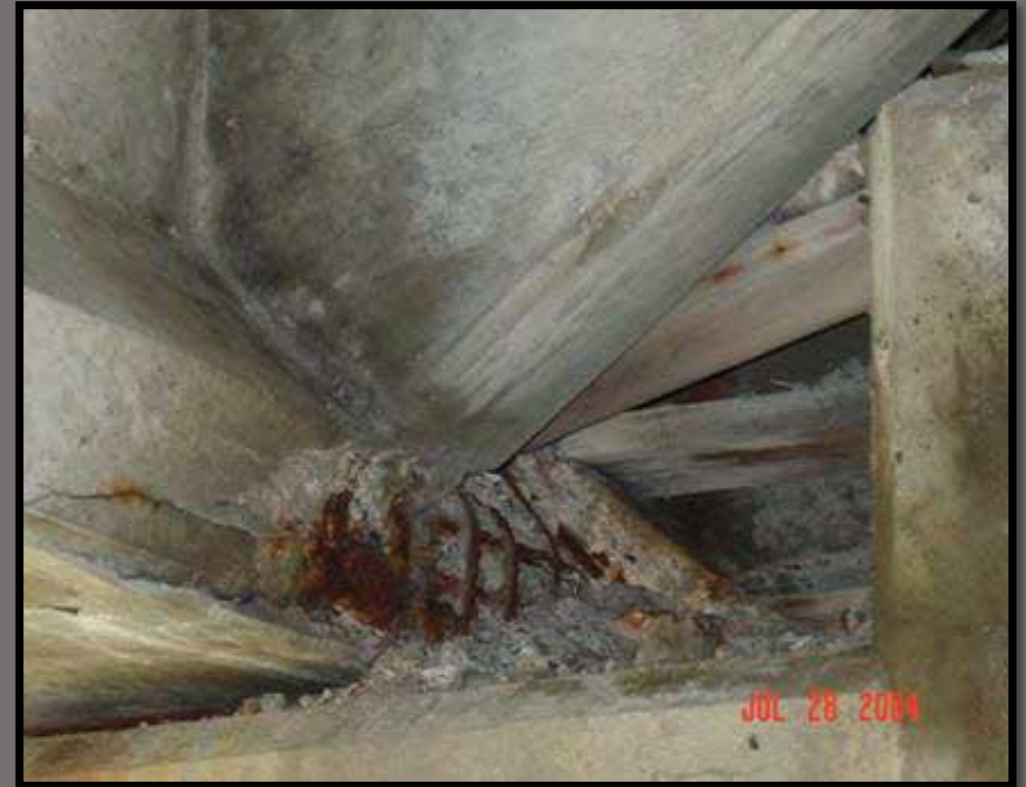
Delamination/Deterioration

Loss of Bearing Area

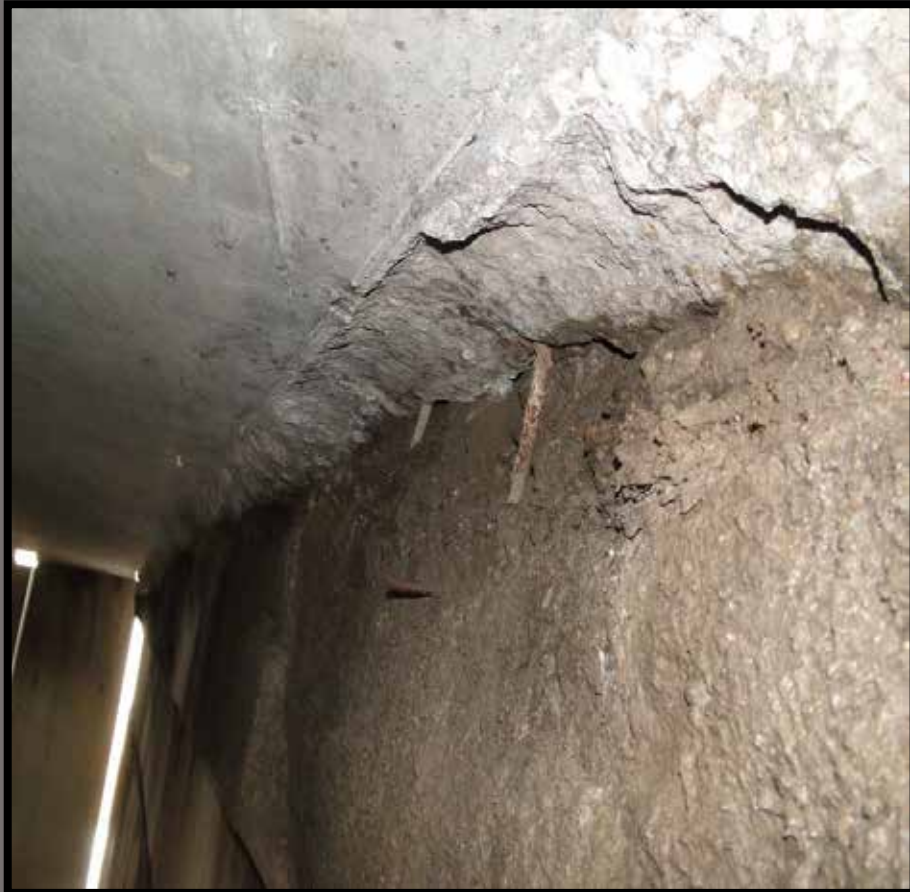
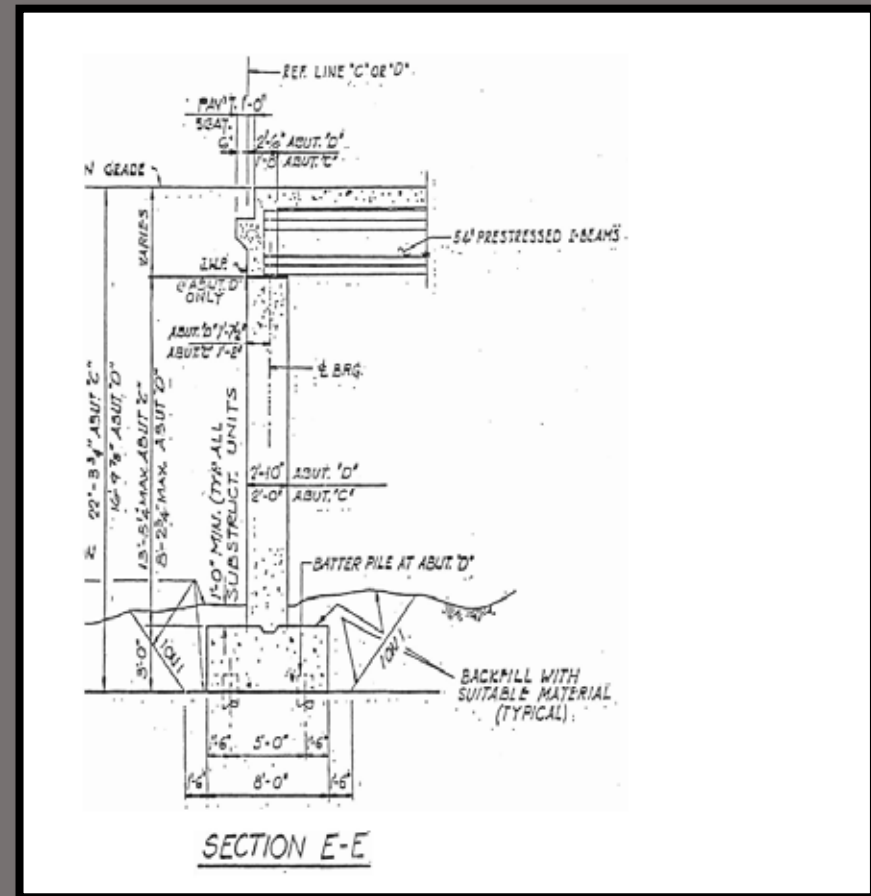
Loss of Bearing Support

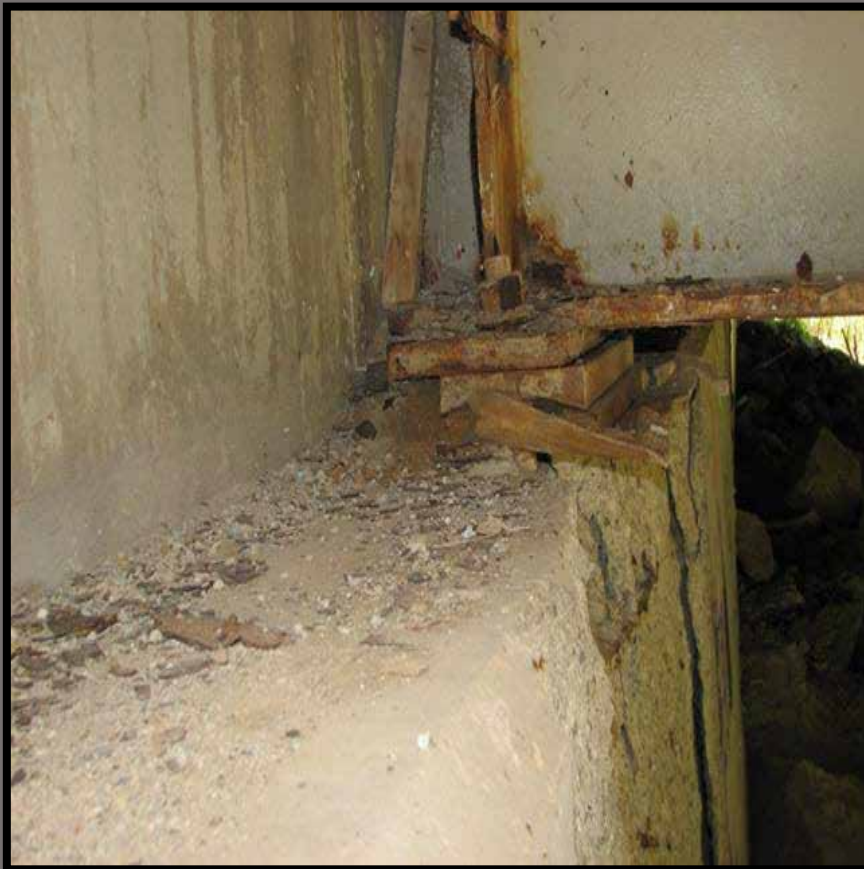
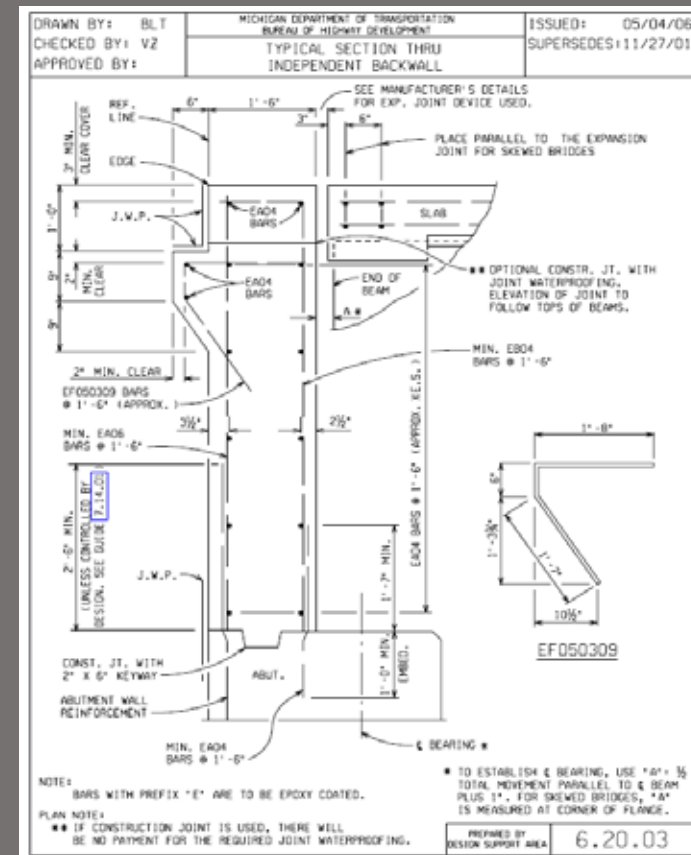
Abutment Spall: Independent Backwall

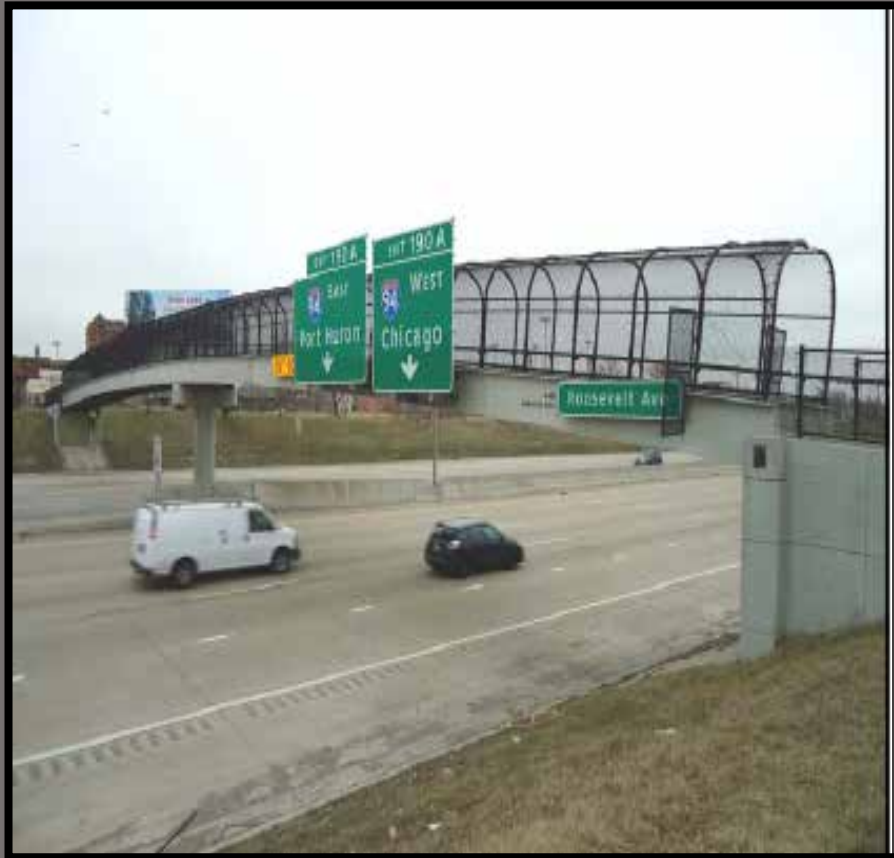
Independent Backwall

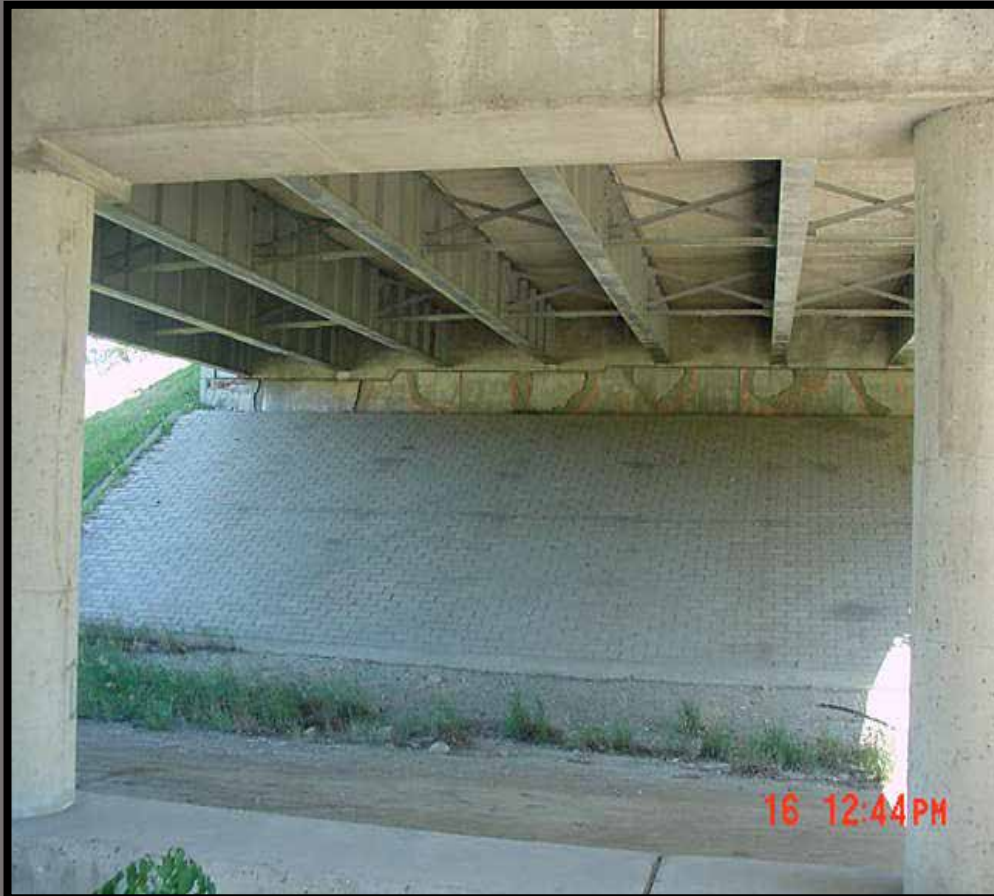
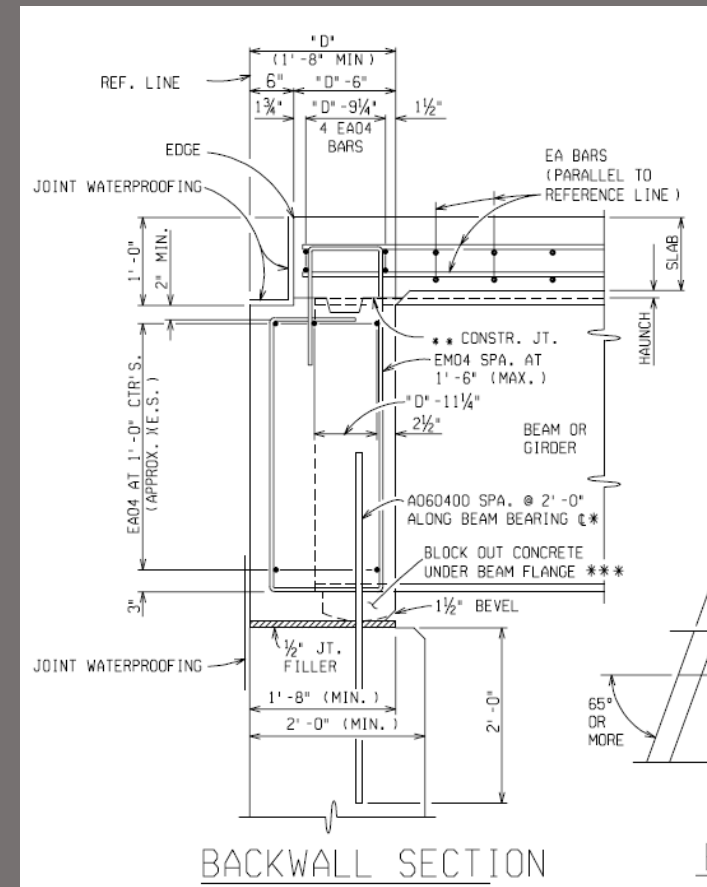
Dependent Backwall

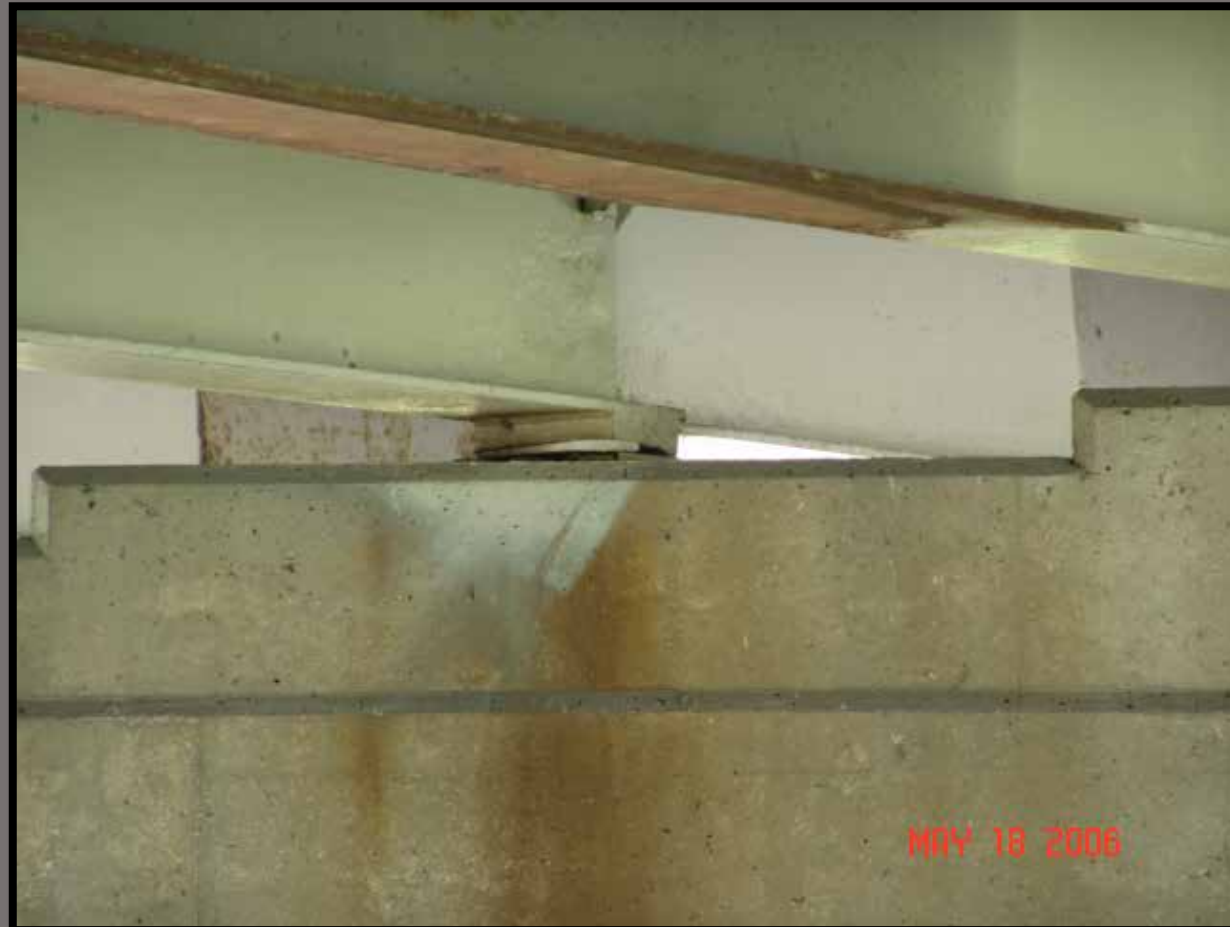
Displaced Bearing Plate
