2024 Bridge Week Conference High Load Hit/Request for Action

By: Christopher Idusuyi
Structures Specialist Engineer and
Bridge Emergency Coordinator

March 12-14, 2024

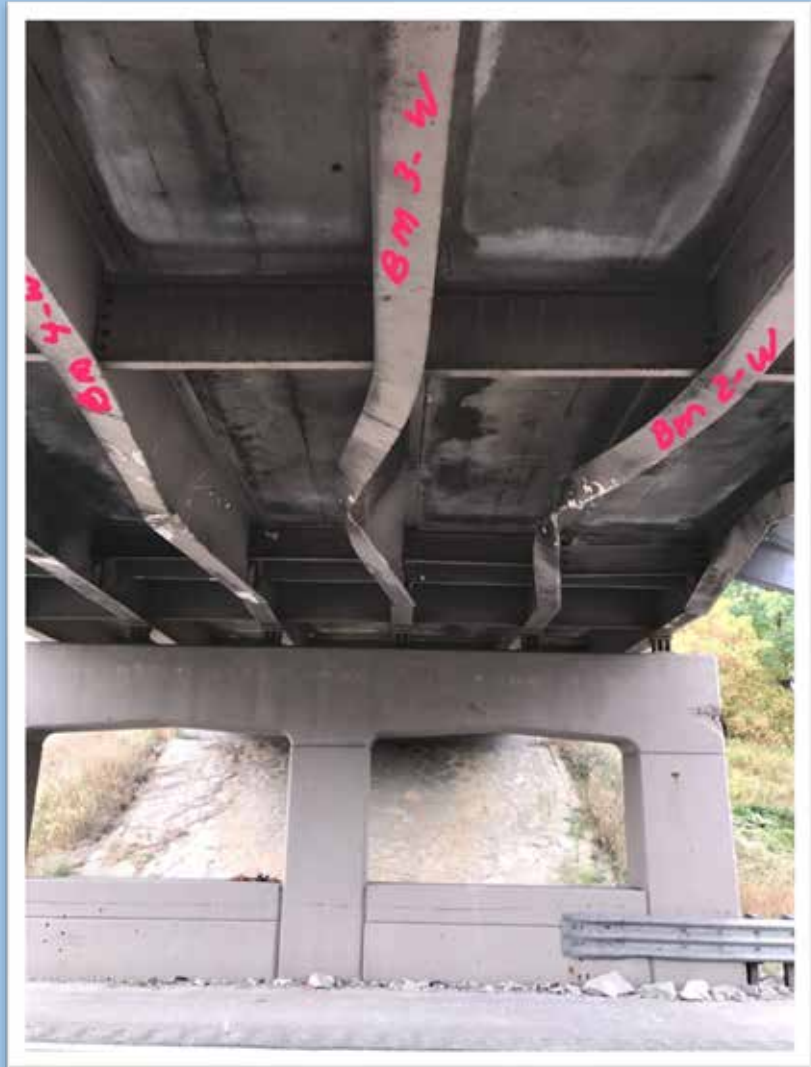
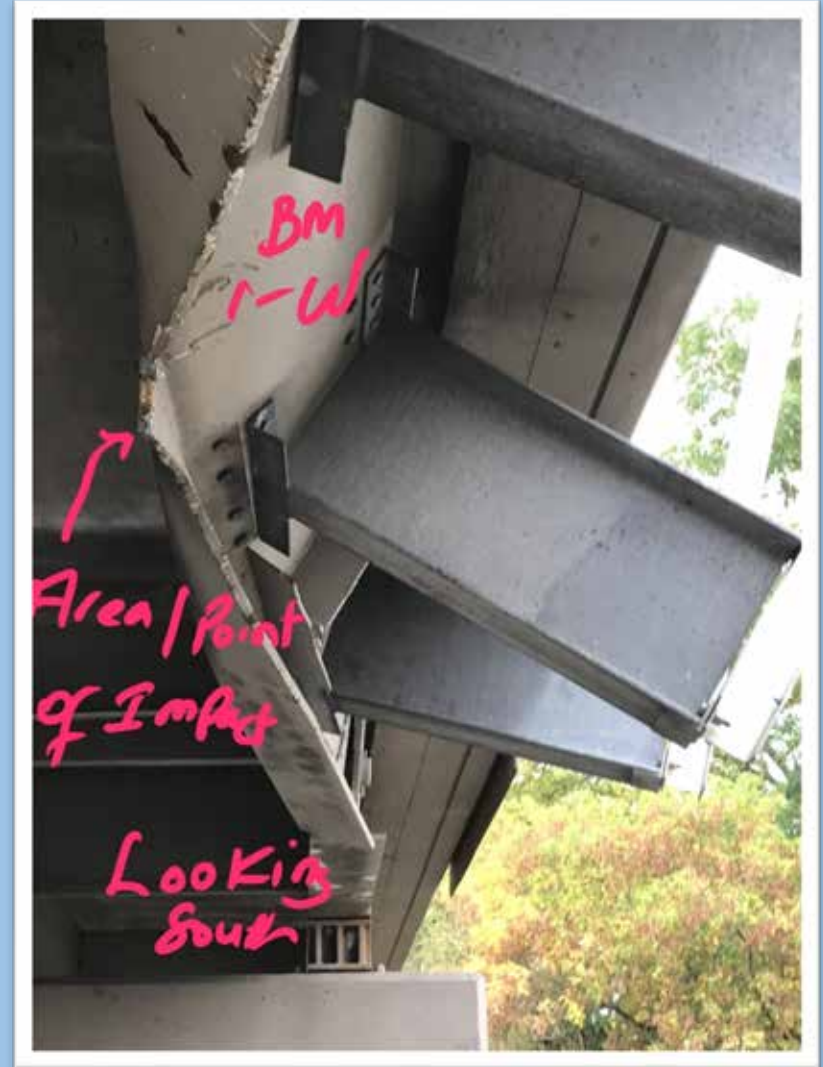
Pleasant Valley Rd over I-96

- § Total span length 231'
- § Built in 1958
- § Bridge hit 2 times
- § Span 2S with length 65' 6"
- § Beams 1W through 4W impacted
- § Beam type W33 x 141
- § Total estimated cost for repair \$581,665

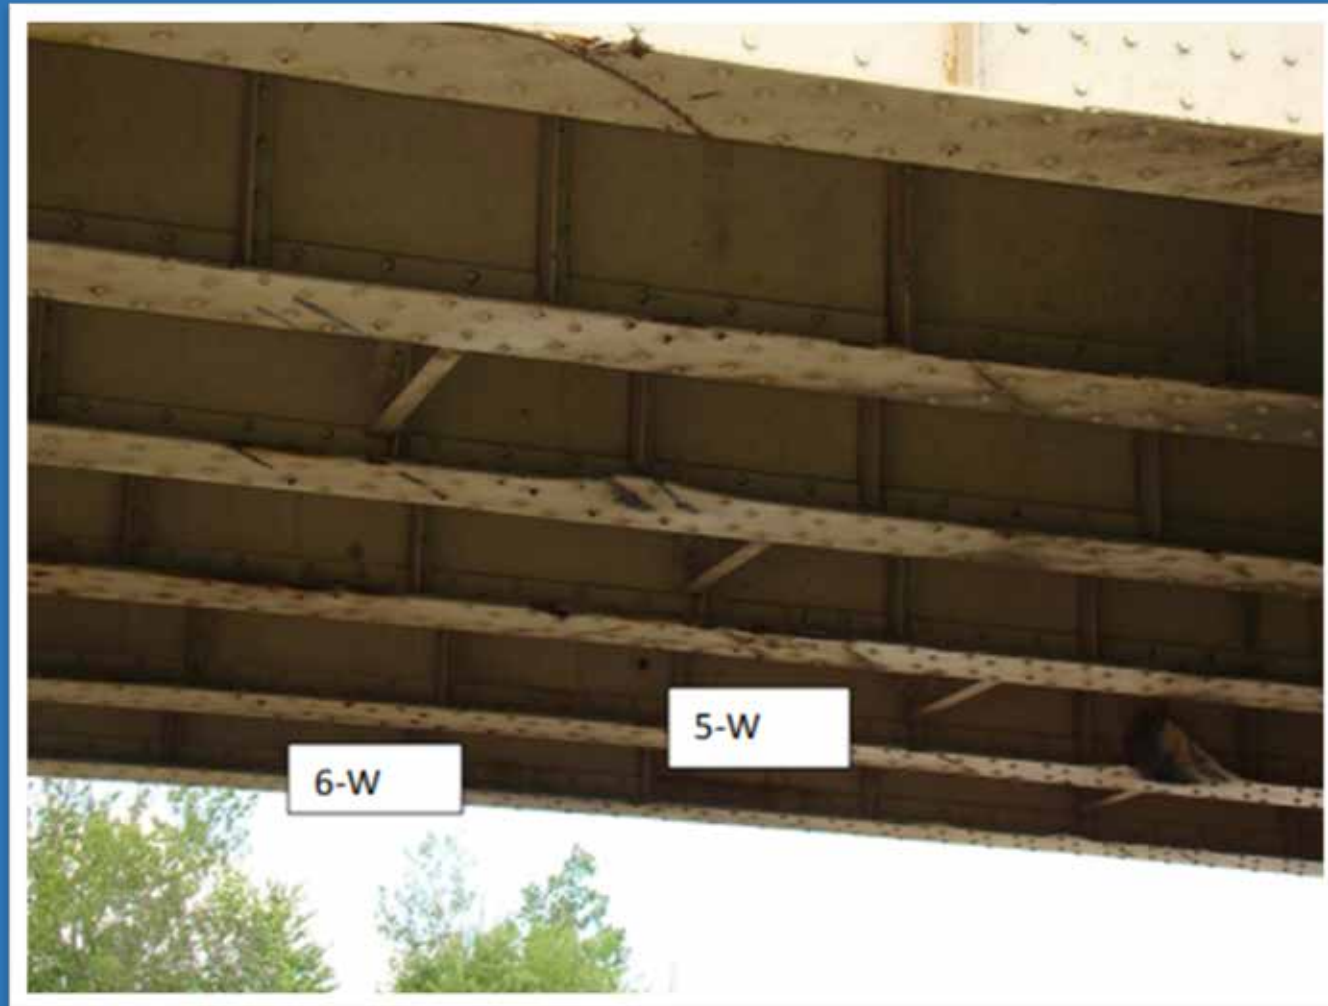
Whitneyville Road over I-96

- § Total span length 275' 6"
- § Built in 1959
- § Bridge hit 3 times
- § Span 3S with length 65' 6"
- § Beams 1W through 6W impacted
- § 60" web length Girder
- § Total cost for repair \$75,107.61

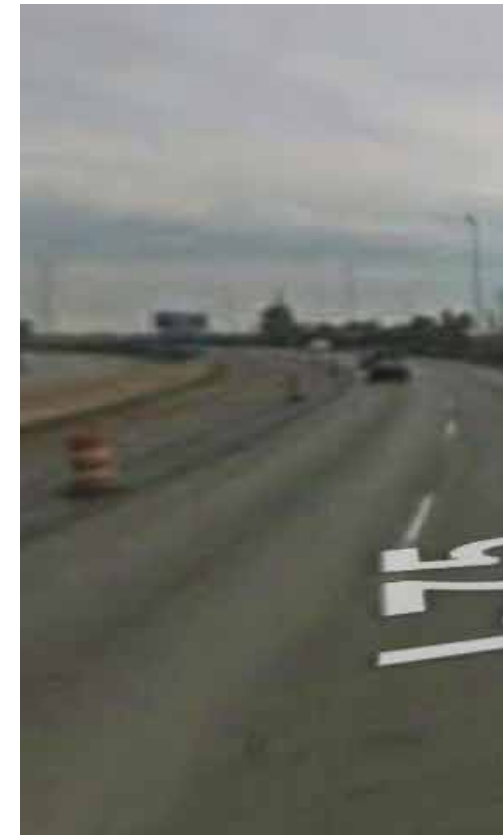
Fire damage on I-75 over Rouge River

- Tanker Truck Explosion caused severe fire damage
- Superstructure and substructure were damaged

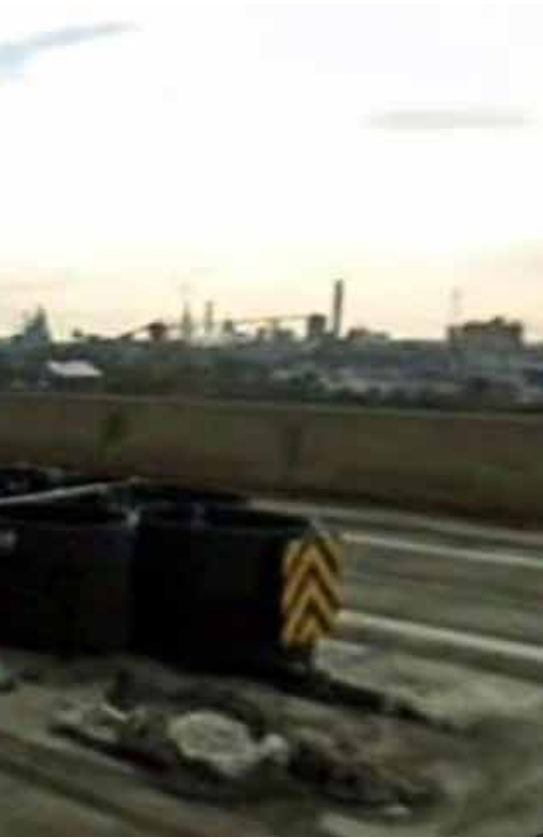
Fire damage on I-75 over Rouge River

- Tanker Truck Explosion caused severe fire damage
- Superstructure and substructure were damaged

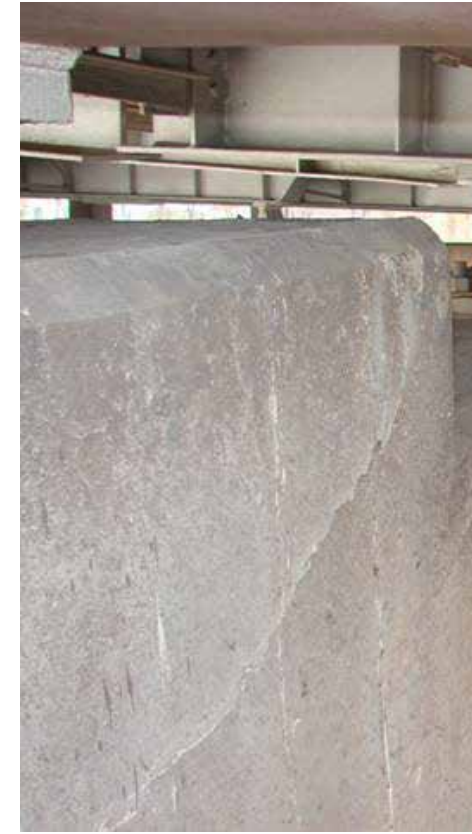
Fire damage on I-75 over Rouge River

- Tanker Truck Explosion caused severe fire damage
- Superstructure and substructure were damaged

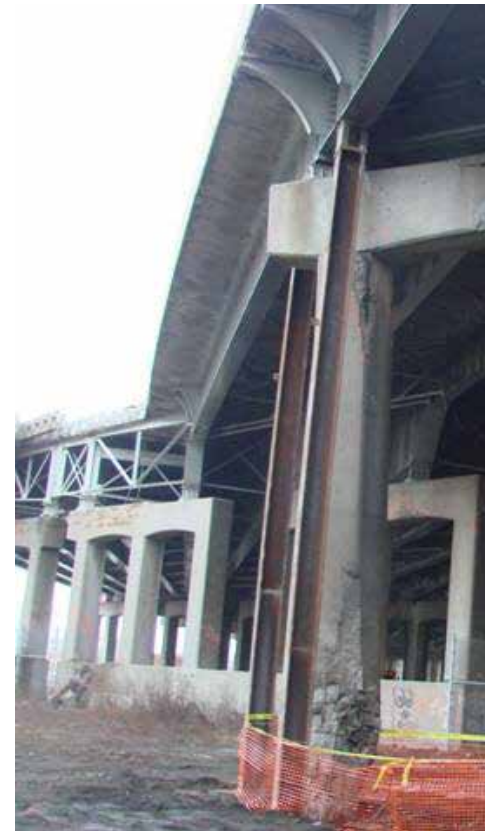
Fire damage on I-75 over Rouge River

- Tanker Truck Explosion caused severe fire damage
- Superstructure and substructure were damaged

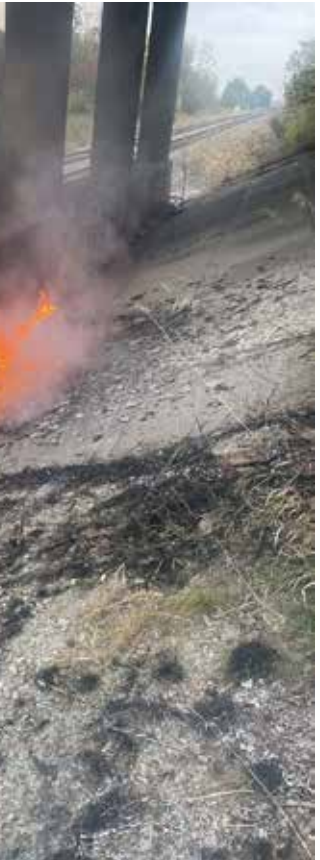
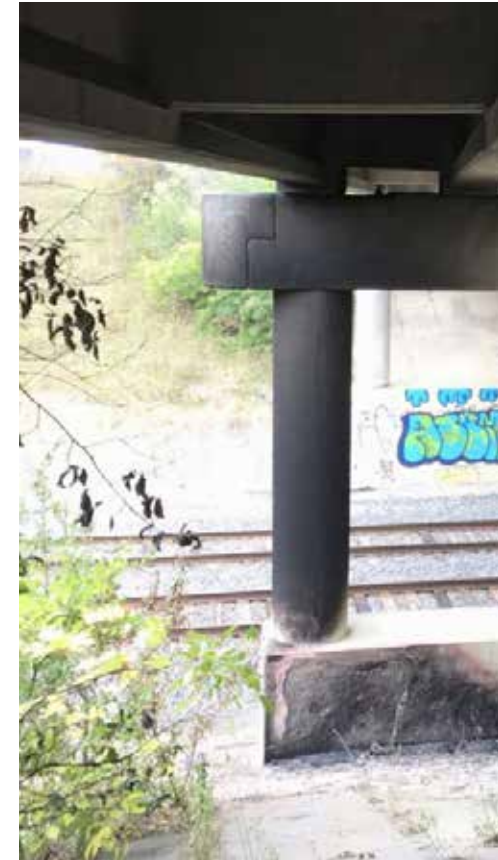
Fire damage on I-75 over MDOT RR Corridor

- Brush fire caused by kids
- Black soot covers south face of Pier 1S

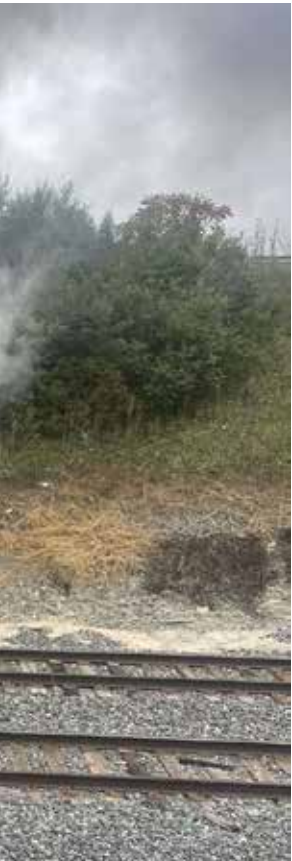
Fire damage on I-75 over MDOT RR Corridor

- Brush fire caused by kids
- Black soot covers south face of Pier 1S

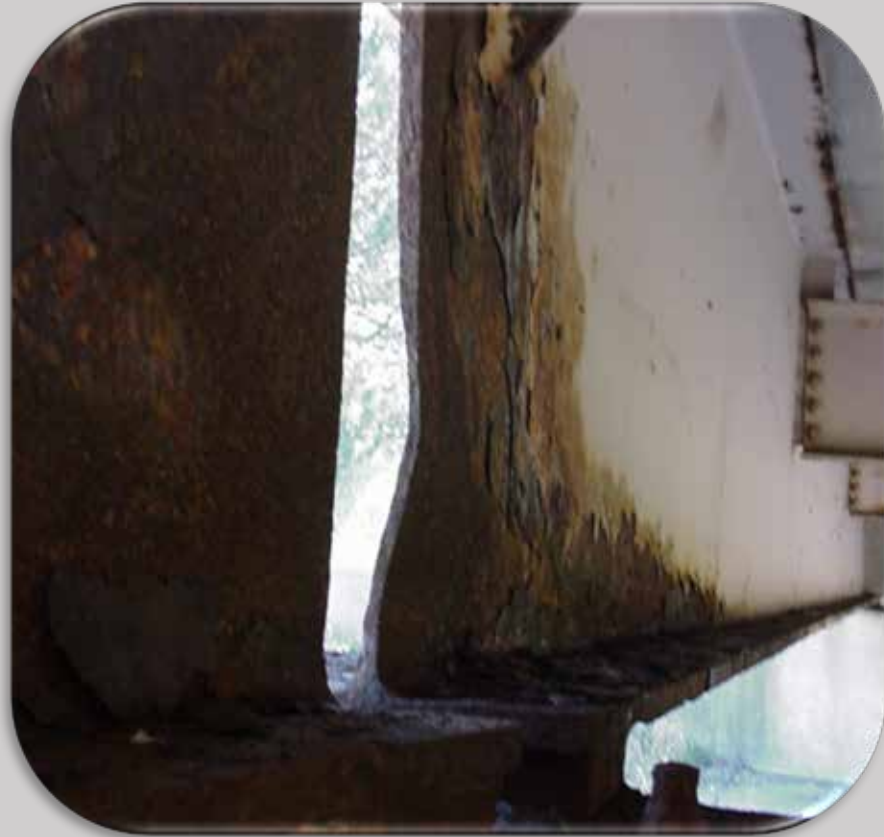
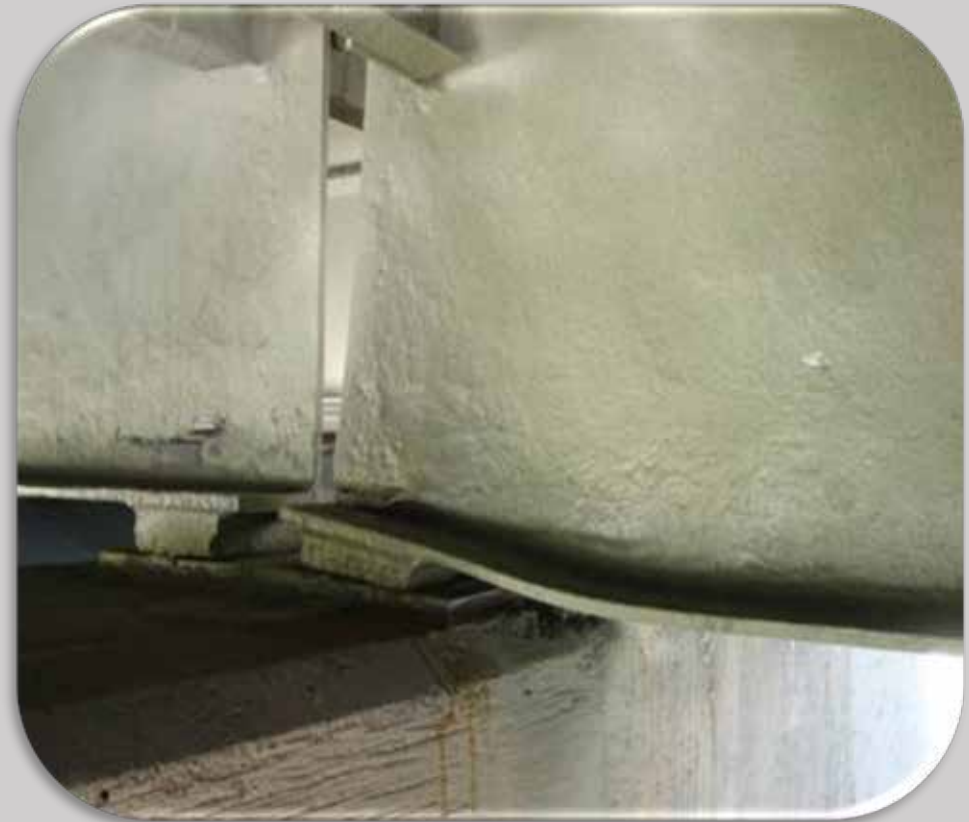
Section Loss

Buckled Beam Ends

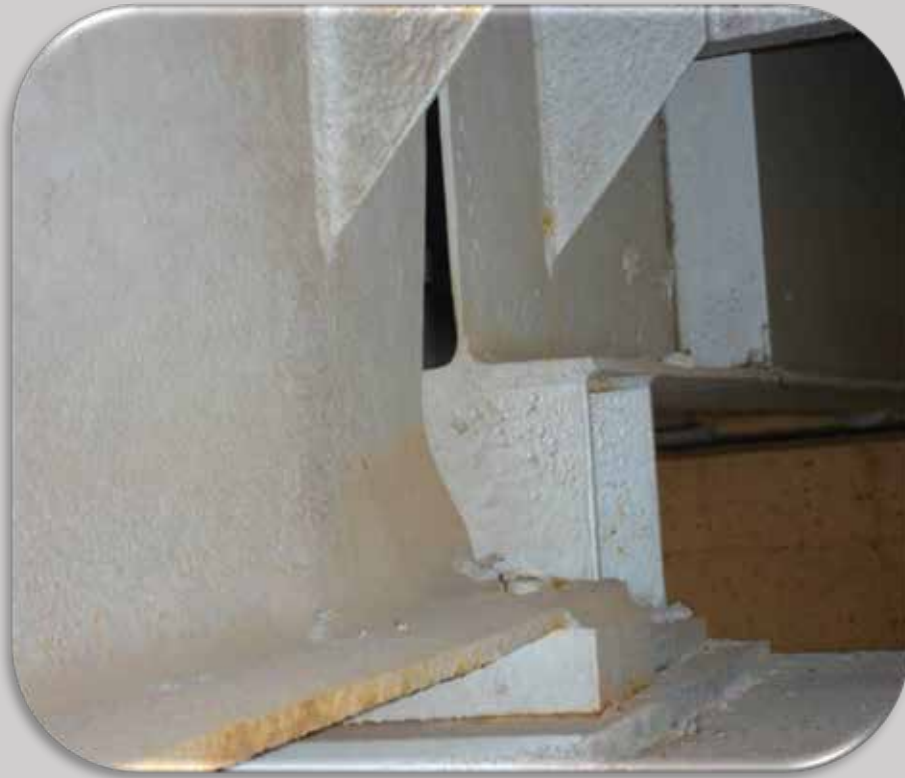
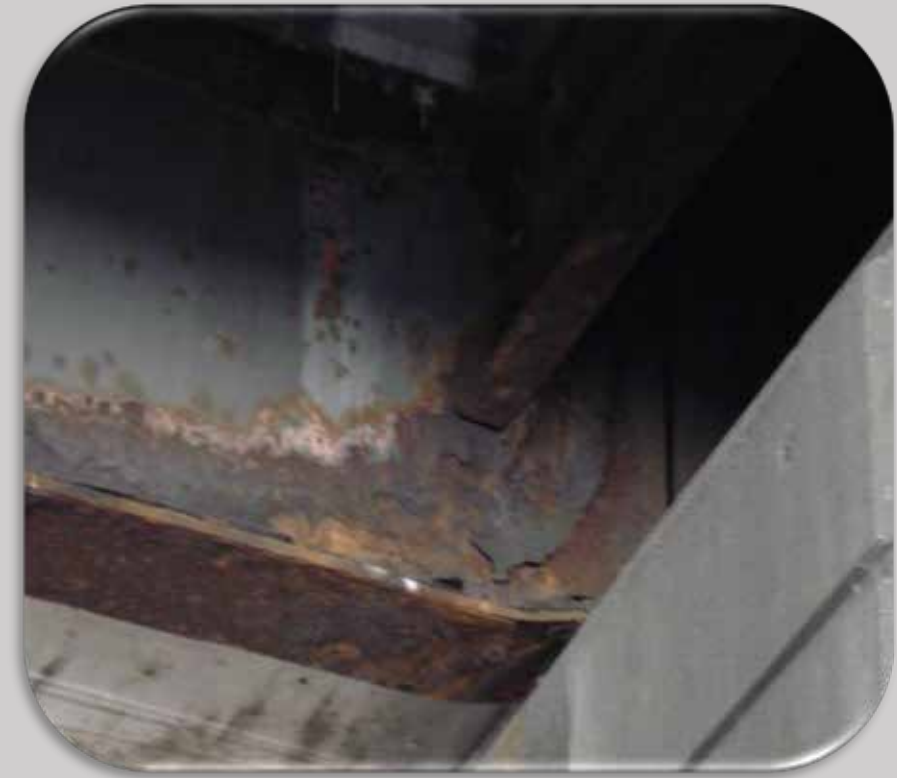
Section Loss

Buckled Beam End due

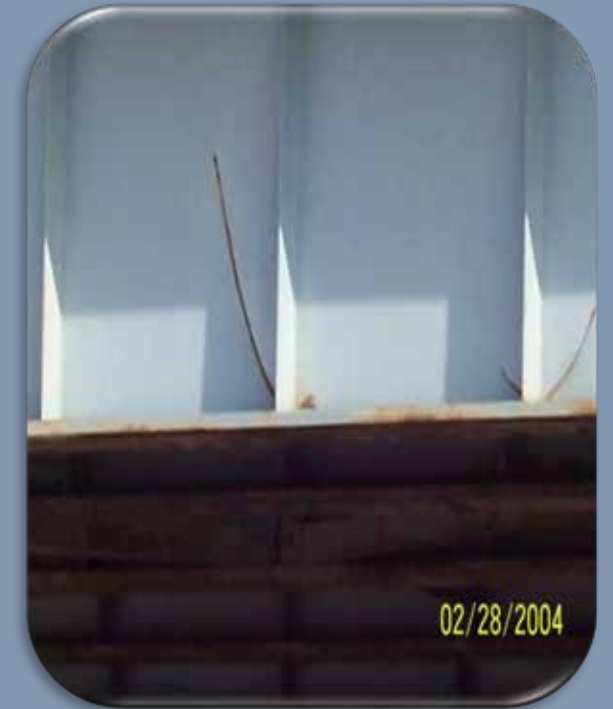
- Fatigue damage (cracked beam)
- Web/stiffener connection
- Fatigue crack because of no weld gap (intersecting weld)

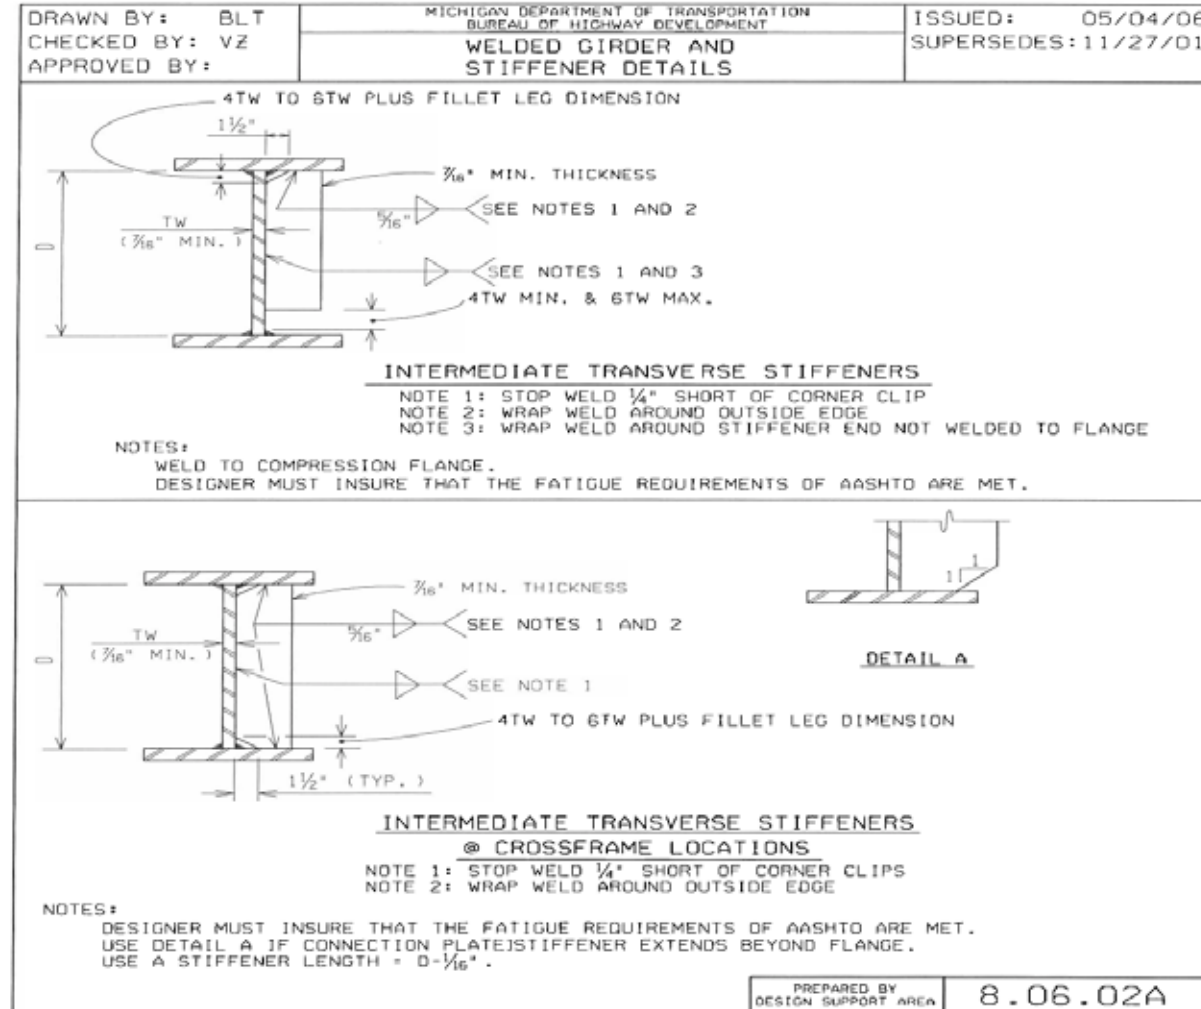
Fatigue
